## **SERVICE BULLETIN**

Product :	Refrigerator	Bulletin No.	2010-Ref-02
Model :	RSH ** model	Bulletin Date :	2010/03/30
Buyer :	All	ECN No.	: -

## **SUBJECT: No cooling(Icing up)**

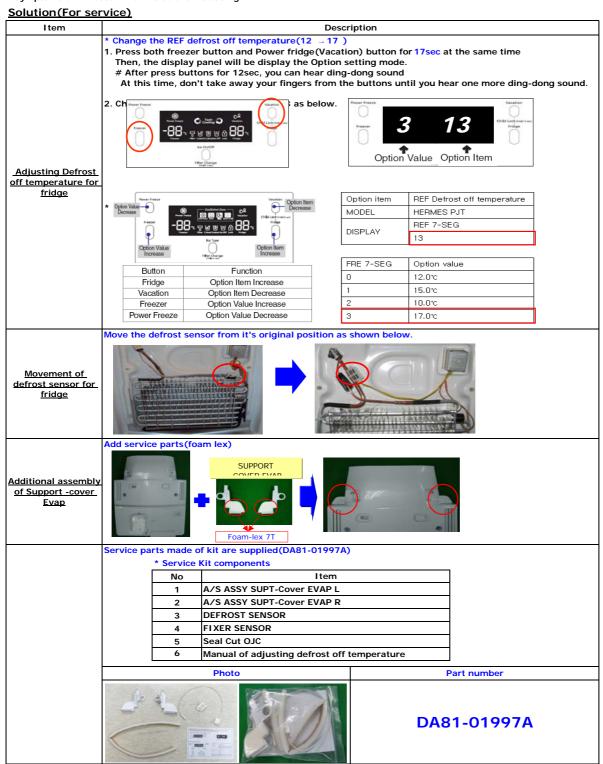
Ice forming at the top of the refrigerator evaporator around the suction tube/capilary pipe where it emerges from liner.

- Suction pipe is touching the liner this can causes dew condensation to form on top left area of evap cover
- Ice ball formation expands around the top left area of evaporator.
- Symptoms are excessive fan noise and no cooing.

Step	Description	Used Part
1	Adjust defrost off temperature refer to Main bulletin	-
2	Disassemble cover evap	-
3	Move the defrost sensor from it's original position as shown below.	Defrost sensor Fixer Sensor
4	Replacement of Seal cover Evap R/L Remove seal damaged from water and then attach new seal	SEAL CUT OJC
5	Assemble Support Cover Evap on deodorizer part  SUPPORT  COVED EVAD  Foam-lex 7T	ASSY SUPT-Cover EVAP L ASSY SUPT-Cover EVAP R
6	Re-assemble Cover Evap	-
