Published by:
Service Department BG Audio

SERVICE NEWSLETTER

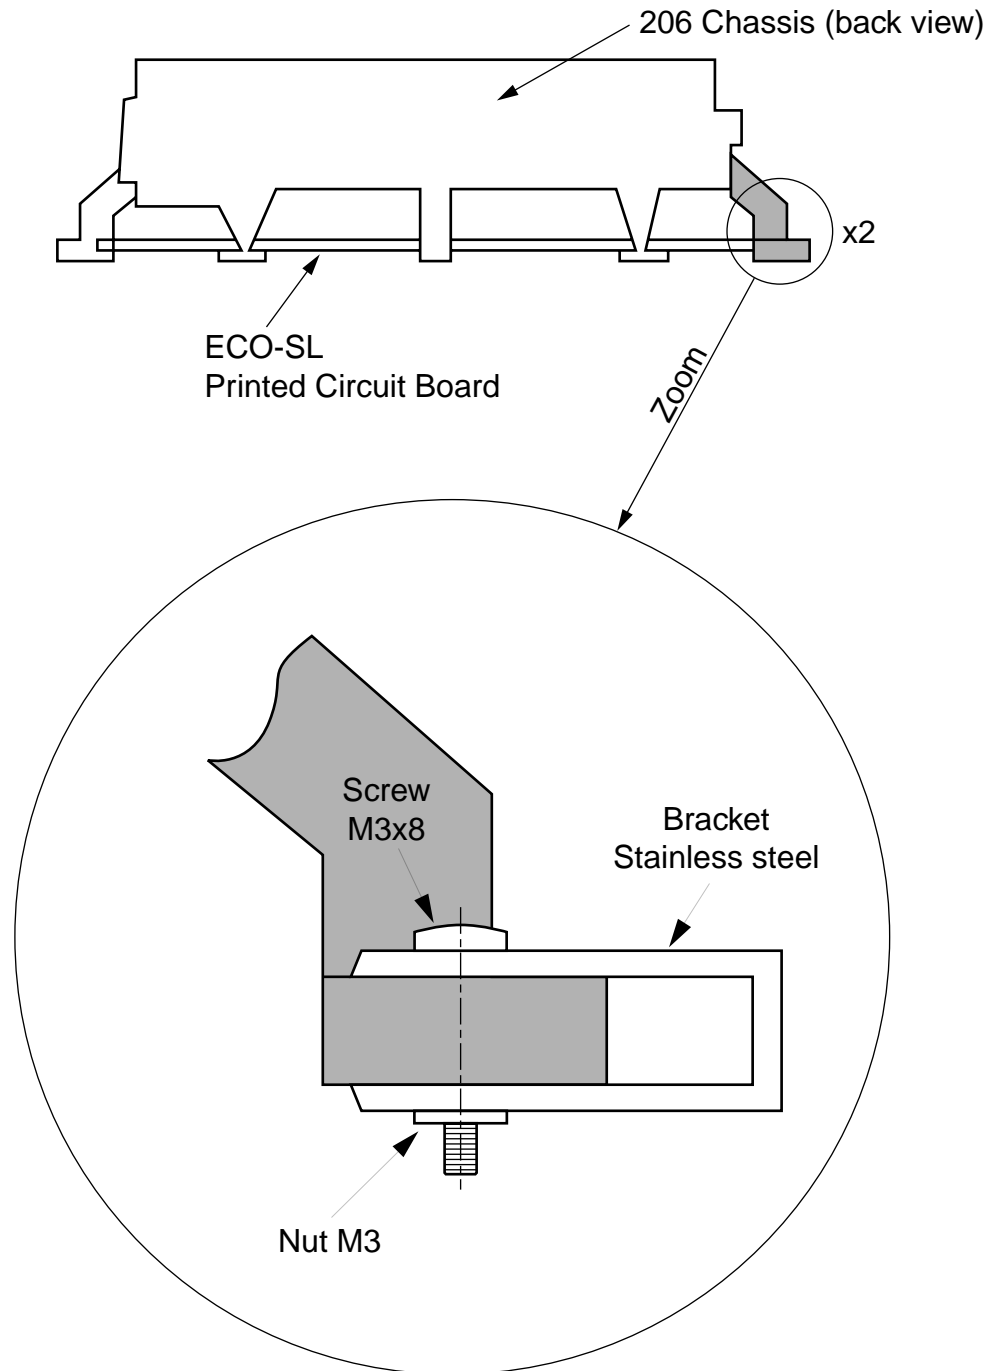
MOUNTING OF BRACKET

CURE : The ECO Short Loader is out of position at the rear fixing slot. This fault might be caused when the set has been dropped.

REMARKS : It is advised to add the brackets in every set, brought in for repair, with production stamp before week 9642.
New Rear Cabinet will be implemented in production from week 9645 onwards.

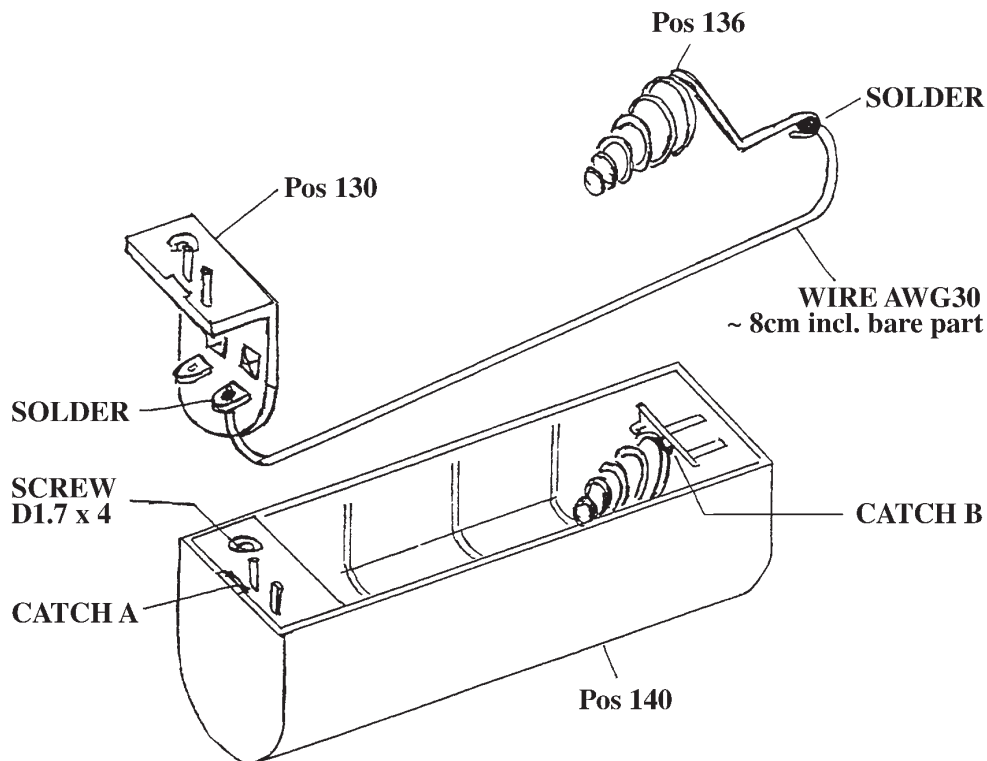
INFORMATION : The battery holder pos. 191 service code: 4822 256 60325 in PCS does not come a wire soldered between the spring connection pos.136 and one of the contacts pos.123. For this reason it becomes necessary that during replacement of this part, the technician must solder this additional piece of wire. Material: Any Black wire of thickness AWG30 cut to length of 8cm including the bare portion at both ends.

1. Unscrew D1.7 x 4 and remove pos.130 by uncatching at catch A
2. Remove pos. 136 by uncatching at catch B
3. Solder the wire as indicated in picture 1
4. Reassemble pos. 130 and pos. 136 into the Battery holder pos.140
5. Dress the wire such that it does not obstruct the battery insertion (into the small groove provided and if necessary hold it down with a small tape).

See next drawing:

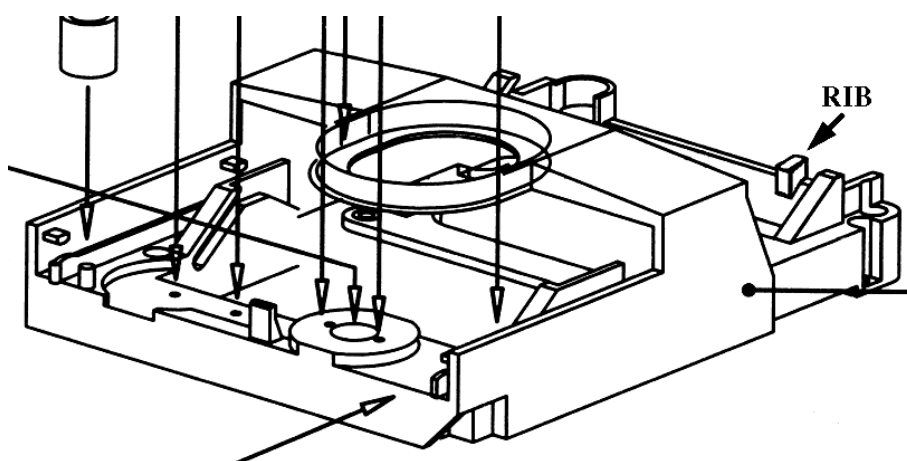
SYMPTOM : Sub-chassis (item 109) is found to be loose on the right front side.

CURE : A rib has been added onto the frame, item 110 (see draft below).

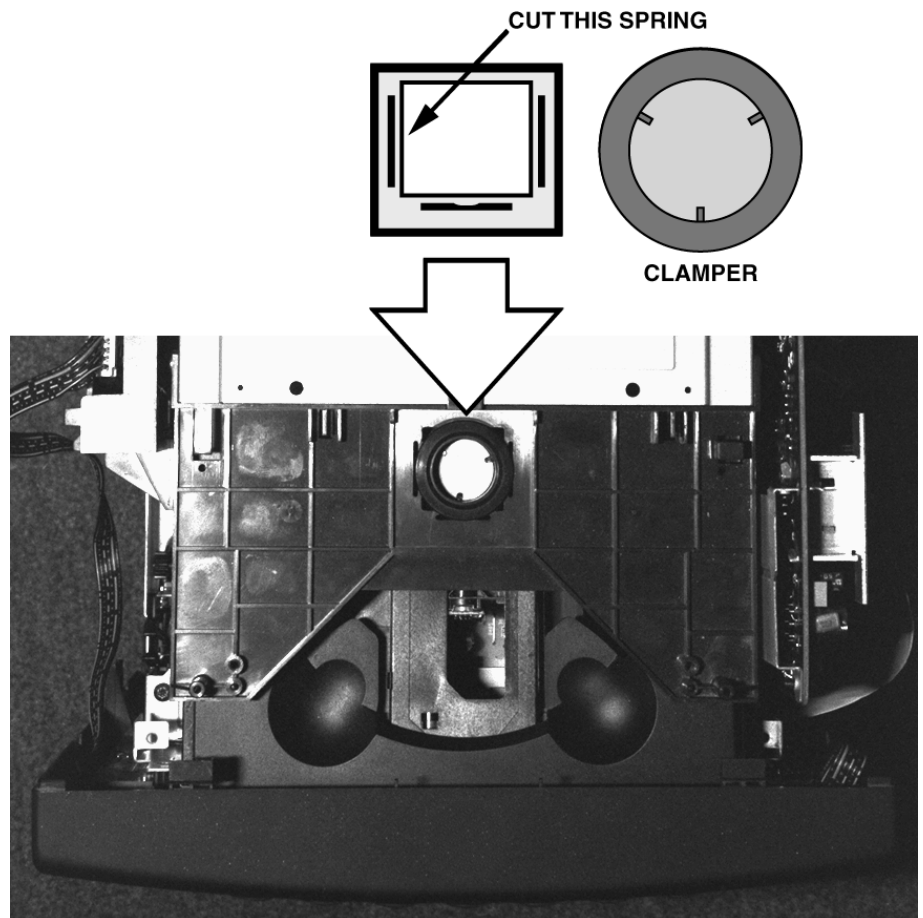
SYMPTOM : After transports - when the set is dropped down at the right hand sidewall - sometimes the clamper is jammed. Sometimes the clamper is pushed back when the CDM comes into play-position, but it may also happen that the clamper jams completely.

CURE : Cut the left hand plastic spring (see sketch below), then the CDM is ALWAYS able to push the clamper back.

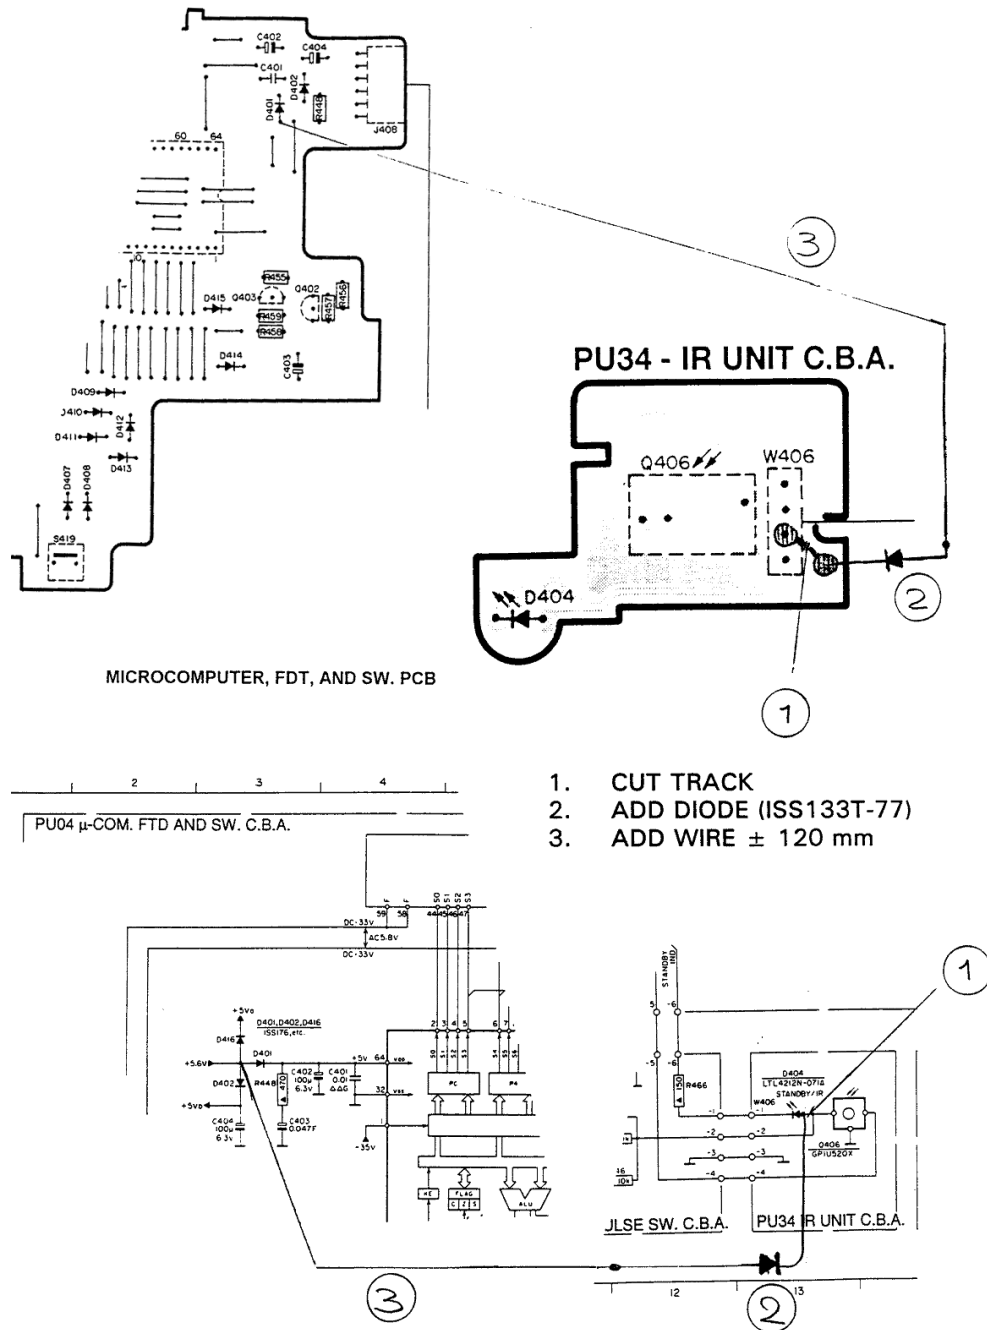
1. CUT TRACK
2. ADD DIODE (ISS133T-77)
3. ADD WIRE ± 120 mm

1. Cut PC Board track between D404 and Q406
2. Add diode 1SS133T-77 (4822 130 33305)
3. Add wire (~120mm) between junction D401/D402 to D404 positive

Referring to next Figure. Part of schematic and layout drawing.

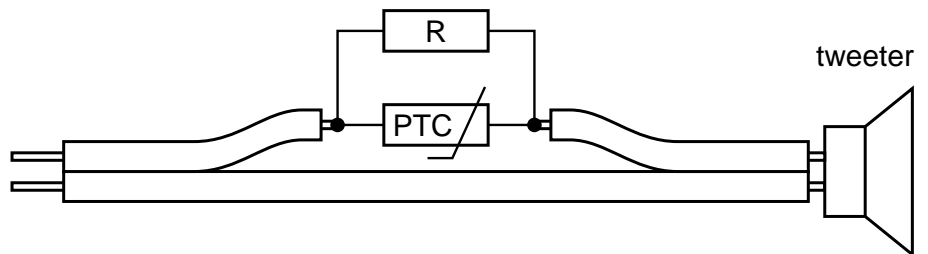
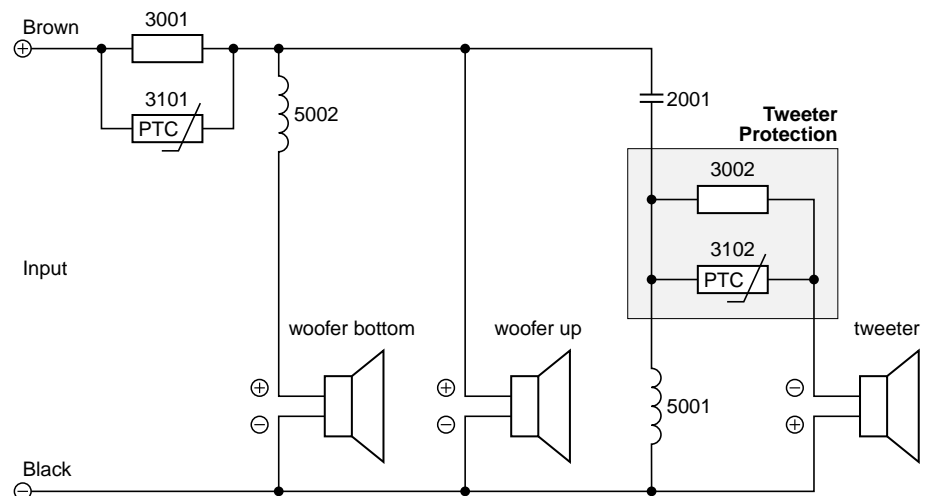
INFORMATION : **Service hints:**
 For loudspeakerbox produced before week 9545 and brought in for repair of a defective tweeter AD11401/T6 (4822 240 70223), it is necessary to add a tweeter protection circuit in the wire to the tweeter.
 See next drawings or service information A95-101 (4822 725 24783).

The extra components used are:
 R = resistor 5.6Ω 5Watt (4822 053 32568)
 PTC = PTC RXE040 (4822 116 40264)

REMARKS : This modification should be applied in each box FB695 and FB696 offered for repair.
This publication will be followed by Service Information A95-101.
