Reference no.: **SCC\_109324**

TV set type 40PUx6809/xx is not powered

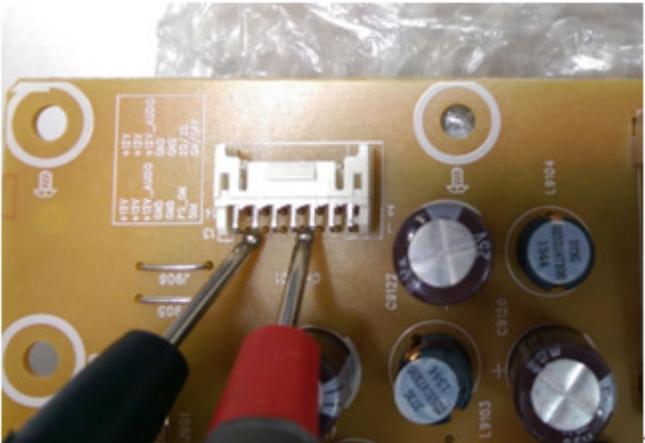
### Step 1

- On the PSU board, check with a multi-meter if there is 12V output on Pin13, Pin5 being GND.
- If no 12V output is measured, then proceed with step 2.

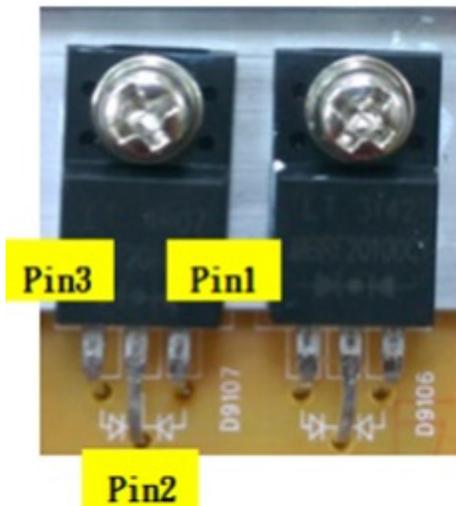
### Step 2

The power failure is caused by one or two defective diodes for 12V supply on the PSU board.

- Remove diode D9106 and/or D9107 from the power board.
- Check the diode(s) on short circuit, with a multi-meter measure the resistance between Pin2 and Pin3 and/or between Pin2 and Pin1 and record in the table below.

- c. If the diodes are defective, then remove the PSU board and perform the following replacement:
- Central Repair Workshops (CSPs) replace both diodes: Proceed with Step 3.
  - General Workshops replace the entire PSU board: Proceed with Step 4.
