Published by:
Service Department Audio

BUSINESS CREATION UNIT AUDIO

SERVICE NEWSLETTER

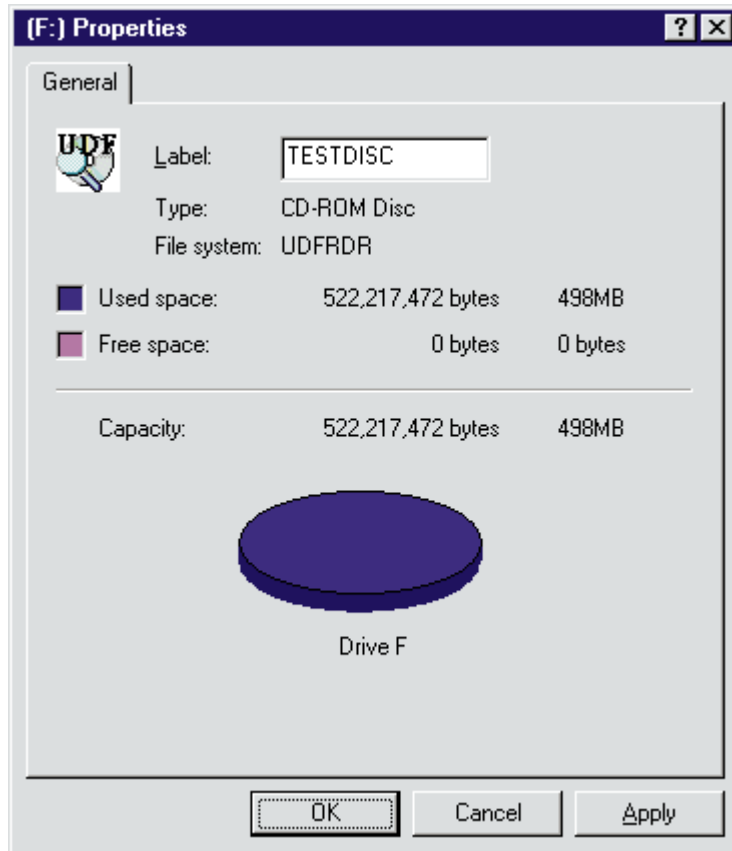
SYMPTOM : **IRIS CODE 1 7 2 1**
The set does not play MP3 CD-R / CD-RW discs.

CURE : The problem is caused by the recording format used by the customer. The present hardware/software supports only ISO9600 standard. UDF (Universal Disc Format) discs cannot be played on the set.

REMARKS : UDF discs can be identified on any UDF compliant MS-Windows PC by opening the properties dialog of the corresponding CD-ROM drive.

For UDF discs the file system is detected as “UDFRDR”, “C2UDFFS”, “CDUDF” or similar, dependent on the operating system and the installed drive software. A special UDF-icon is displayed optionally.

The customers should be advised to record their MP3 music discs according to ISO9600 standard.

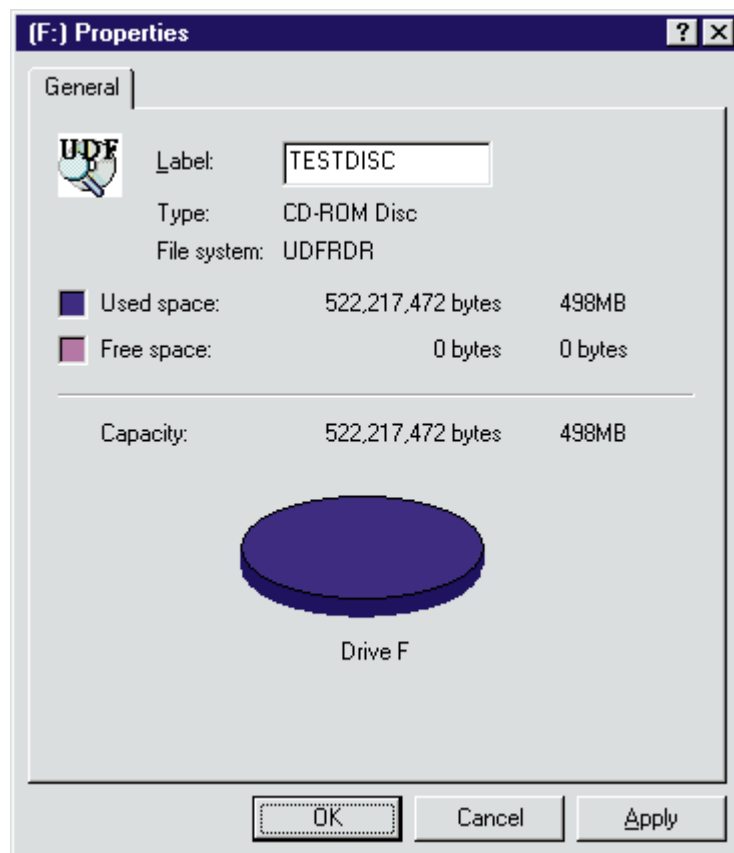
CURE : This problem is caused by the recording format used by the customer. The present hardware supports only ISO9660 standard, UDF (Universal Disc Format) discs cannot be played on the set.

REMARKS : UDF discs can be identified on any UDF compliant MS-Windows PC by opening the properties dialog of the corresponding CD-ROM drive.

For UDF discs the file system is detected as “UDFRDR”, “C2UDFFS” or similar, dependent on the operating system and the installed driver software. A special UDF-icon is displayed optionally.

The customers should be advised to record their MP3 discs according to ISO9660 standard.

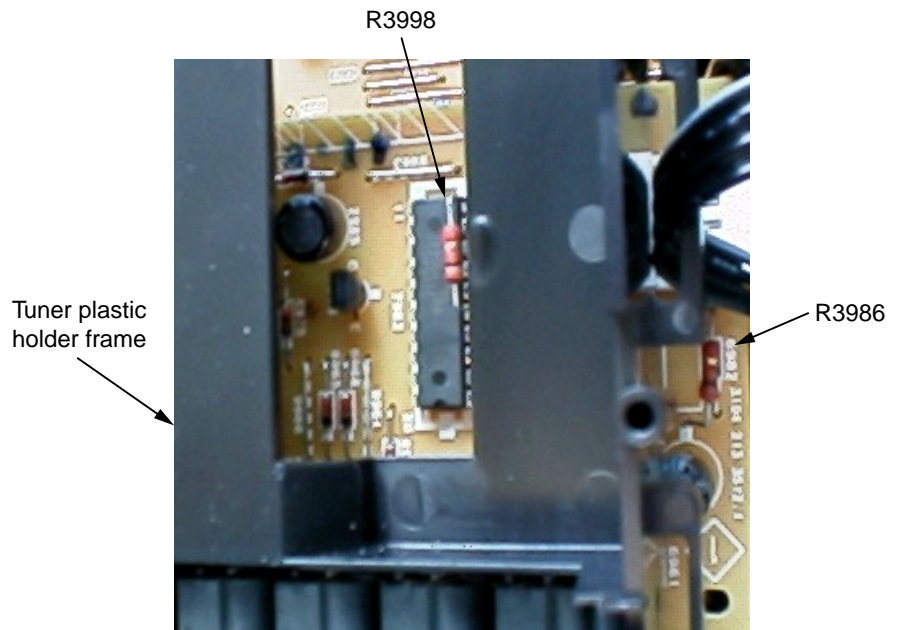
- SYMPTOM** : **IRIS CODE 1 1 6 F**
The set gives a burning smell.
- CURE** : Safety resistors 3986 and 3998 on the S-VHS Video Selector Board are mounted too close to the Tuner plastic holder frame.
In order to solve the problem, bend resistor 3986 approx. 40° towards diode 6982 and bend resistor 3998 approx. 40° towards IC7962.

IMPORTANT: It is essential to check all sets brought in for repair and to carry out above modification if required !!

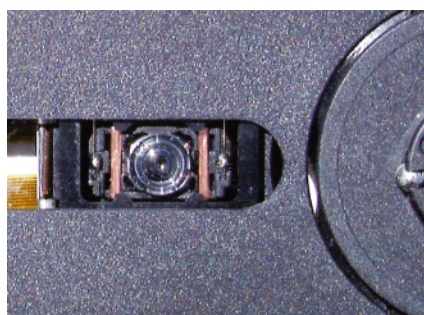
DA23LPH – black lens holder

INFORMATION : Above mentioned typenumbers are produced with different CD-drives: DA23LPH and DA23LNPH. The drives can be identified by the color of the lens holder:

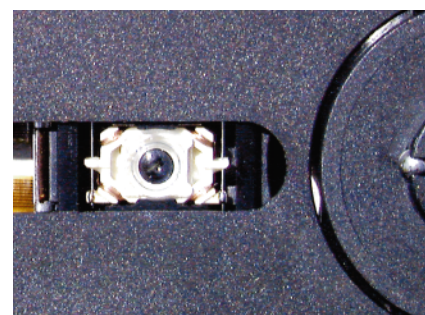
DA23LNPH – white lens holder

DA23LPH is no longer available as service sparepart and has been standardized to the newer DA23LNPH – 3103 309 05320.

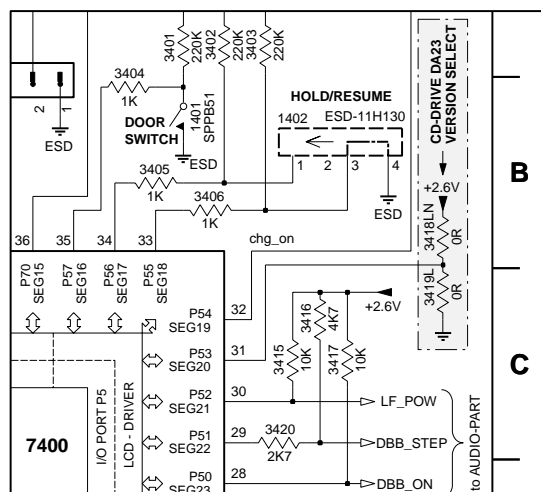
The new drive requires different software parameters and will not work properly without the following hardware modification:

1. Remove pull-down resistor 3419L
2. Add pull-up resistor 3418LN

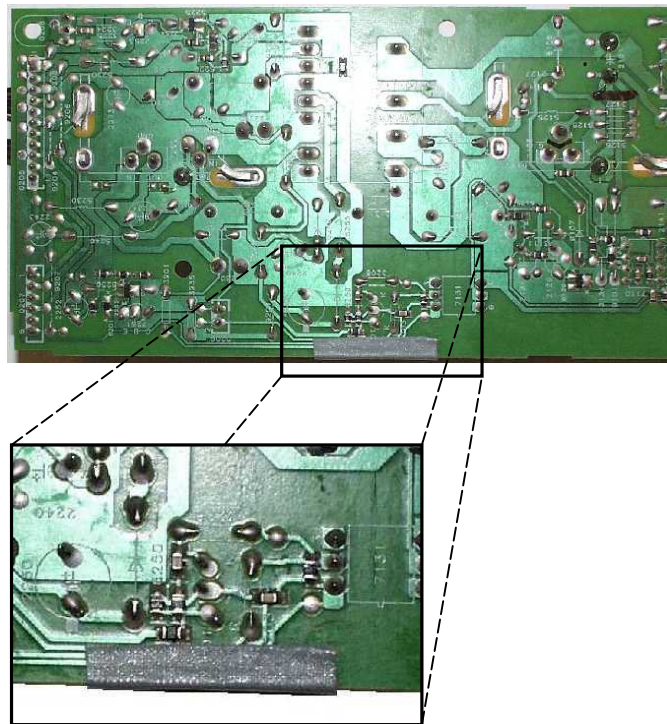
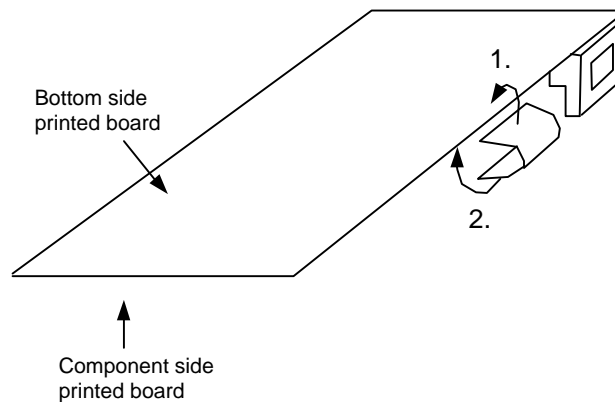
CURE : The copper tracks on the soldering side of the Power Supply Unit “PSU CDR3 ECO” run too close to the edge of the printed circuit board. This may cause

- a mechanical disruption of the copper tracks or
- a short-circuit to the metal backplate which in turn damages resistor 3201.

To solve this problem it is advised to fix a 2.5 cm piece of insulating tape (i.e. TESA 4657, width = 1 cm) to the edge of the printed circuit board as shown in pictures below.

REMARKS : The insulating tape has been implemented in production from week 0105 onwards. It is recommended to check all sets brought in for repair.

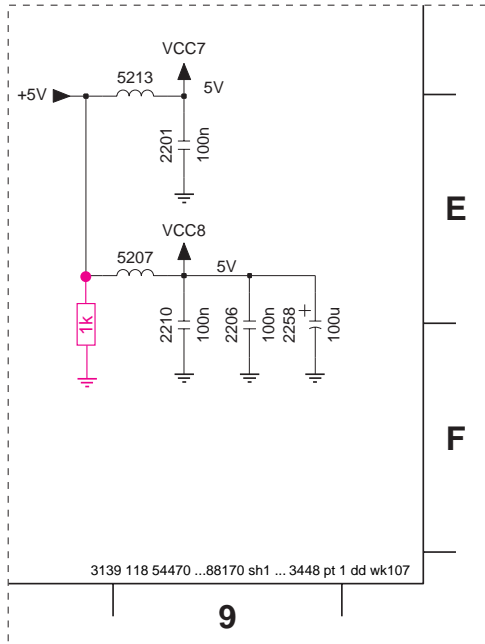
Portion of Circuit on page 8-7

- SYMPTOM** : **IRIS CODE 1 5 4 2**
No music, only noise is audible during MP3 playback.
- CURE** : Due to residual voltage, the MPEG board does not get a proper reset.
- The problem can be resolved by the following rework (see drawings on next page):
1. Cut a copper track
 2. Add a resistor 1k Ω (4822 050 21002) across +5V and ground
 3. Add a resistor 10k Ω (4822 050 21003)
 4. Add diode 1N4148 (4822 130 30621)

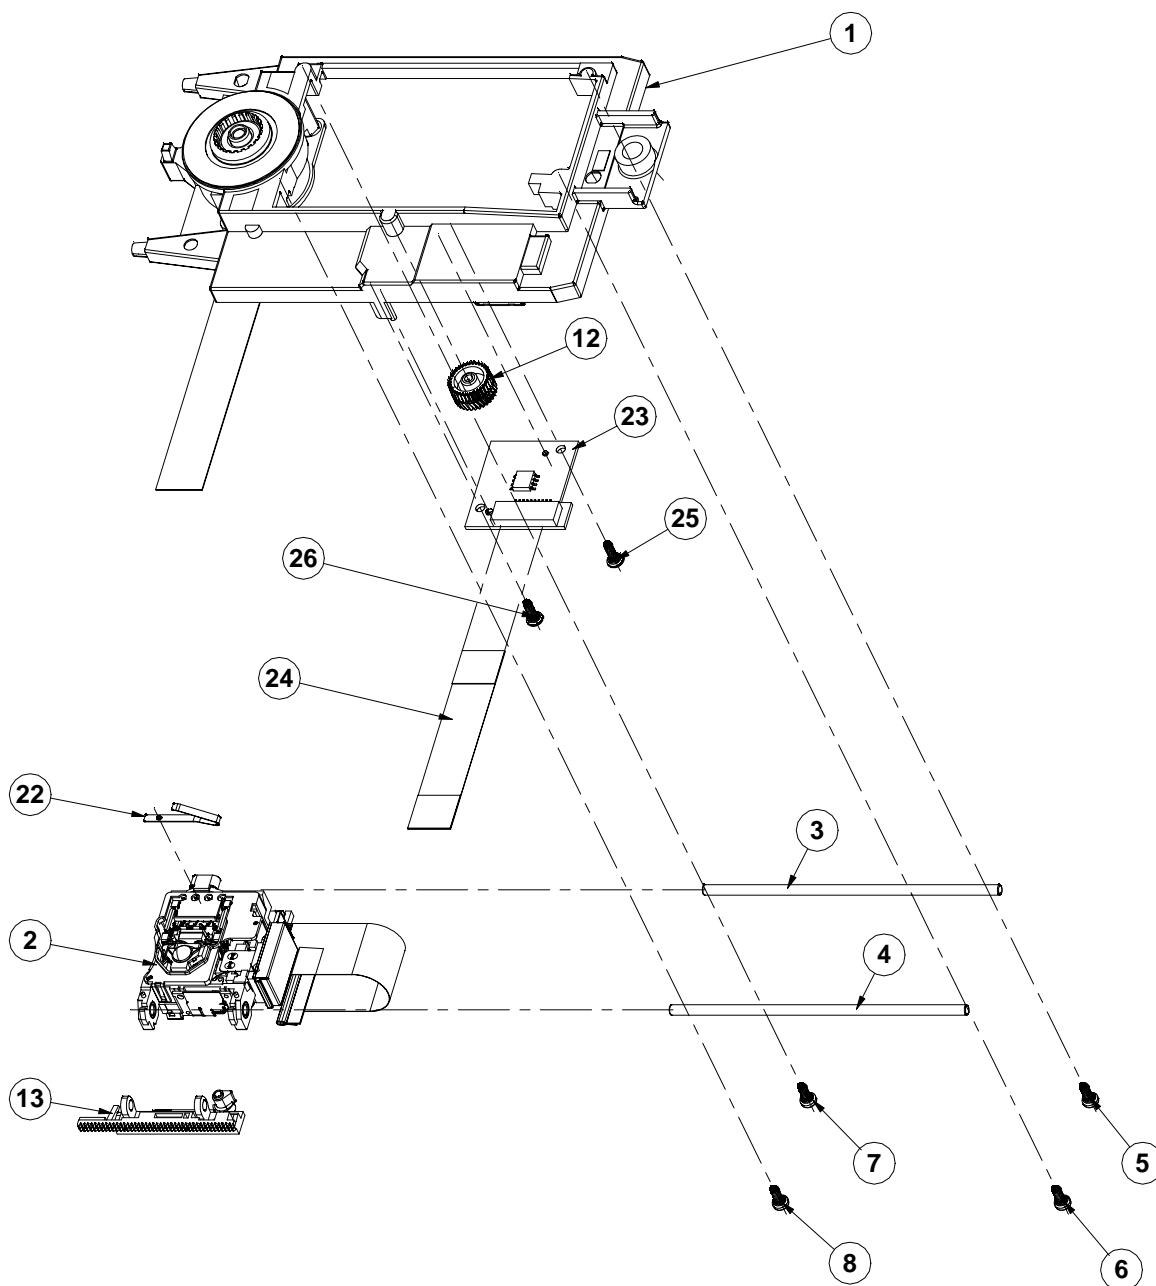
EXPLODED VIEW CDM3800

INFORMATION : In case the Optical Pickup Unit "OPU" (item ②) has to be replaced, it
is absolutely necessary to replace the axle (item ④) at the same
time. For reference see Exploded View CDM3800 on next page resp.
chapter 4.4 of 2nd line Service Manual CDR570,... 3104 125 40110.
Also gear rack (item ⑬) has to be investigated for damages of its
teeth. As follows the instruction how to replace these parts.

- 1.1. First demount loader CDL4009 and CDR-MainBoard as given in
Mechanical Instructions, chapter 4.1.
- 1.2. Now the OPU can be de-mounted. See chapter 4.4 (Exploded
View CDM3800)
- 1.3. Loosen 2 screws (⑥ and ⑧)
- 1.4. Take away the old OPU ② with its axle ④ and gear rack assy ⑬
by lifting it up at that released side and then shift it from it's other
axle ③.
- 1.5. Take care of spring ②. It can be reused for the new OPU.
- 1.6. Remove gear rack ⑬ from the OPU by removing axle ④. If the
gear rack is not damaged it can be reused for the new OPU.

- 3.1. After replacement of the OPU it is absolutely necessary to start ComPair Adjustment procedure immediately. Follow the instructions as given by ComPair.

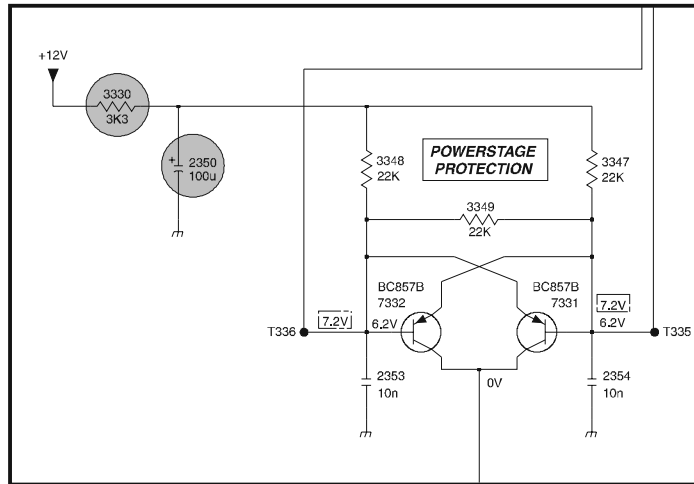
INFORMATION : In course of production, the following components have been added on the Combi Board to improve power muting:
 2350 4822 124 40207 100µF
 3330 4822 116 52269 3.3kΩ

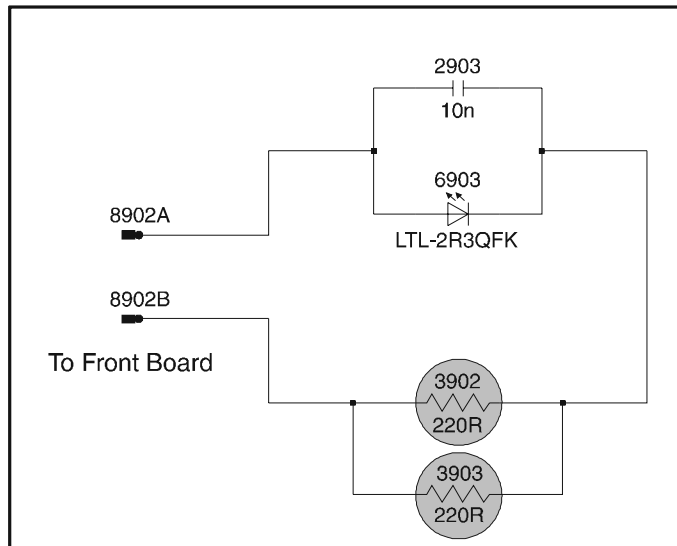
INFORMATION : Backlight board: In course of production, resistor 3903 has been added in parallel to resistor 3902 to prevent overheating. The value for both resistors is 220Ω, available with codenumber 4822 117 11503.

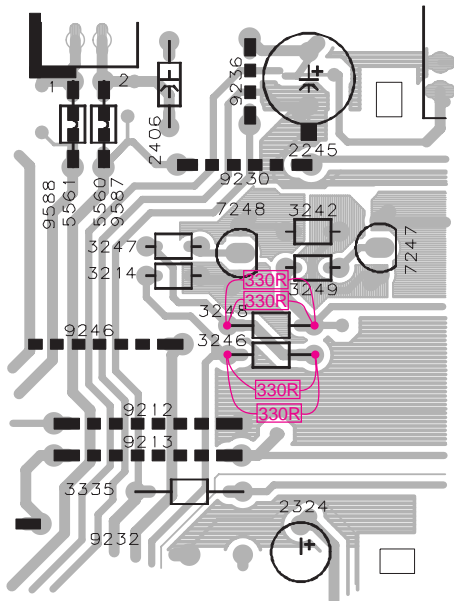
The problem is resolved by the following modification:

1. Replace Elcap 2225 with 4700µF / 25V (4822 124 12012).
2. Replace resistors 3246 and 3248 by 3 pieces of 330Ω 1/6W (4822 116 52219) each as follows:
 - replace 3246 and 3248 by 330Ω 1/6W
 - solder 4 resistors 330Ω 1/6W across 3246 and 3248 on the copper side as shown.

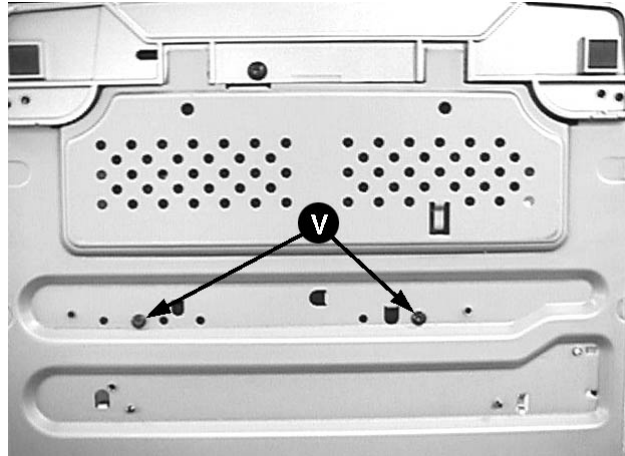
These additional screws have an impact on the dismantling steps given in the Service Manual. The picture below shows the screw location on the bottom plate (see screws V).

Take care when dismantling the DVD/DAC Module.

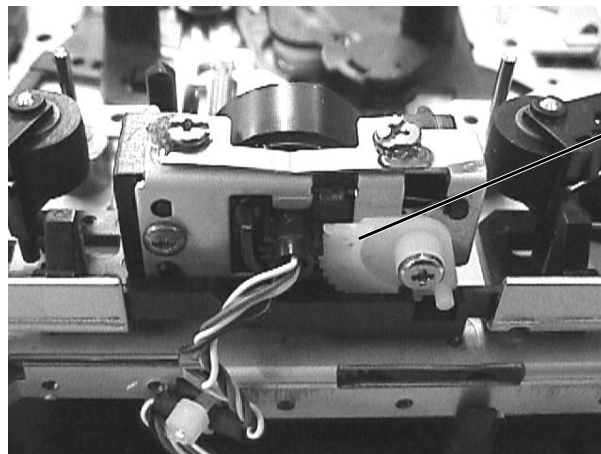
INFORMATION : Tape Deck Record/Playback head replacement tip.
After replacement of the Record/Playback head (pos 1) it is very important to align it to the Forward position as given in picture below. If this is not done, there is risk of damaging the gear.

Turn the Rec/Pb head until the white gear rack reaches this position
