Published by:  
Service Department Audio Systems

# SERVICE NEWSLETTER

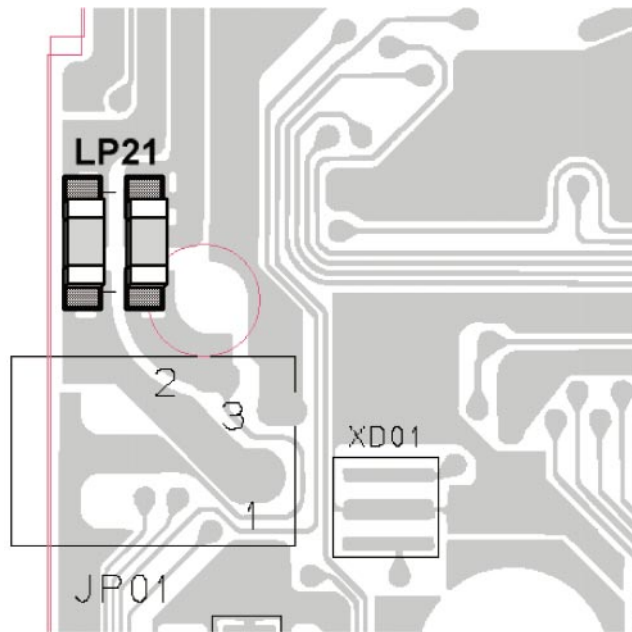
SYMPTOM : **IRIS CODE D 1 1 7**  
Short battery lifetime (less than 40 min. with some Alkaline batteries).

CURE : Short battery lifetime is caused by high internal impedance of some Alkaline batteries. It can be improved by the following modification:  
1. Replace LD09 by a 10Ω resistor (4822 051 30109)  
2. Replace MPU IC QM03 by the updated version (4822 209 17367)  
3. Remove filter LP21  
4. Add 2 SMD jumpers (4822 051 10008) at position LP21

REMARKS : Above modification is implemented in production with production LOT number "21", production code "MZ01 xxxx21xxxx" onwards.

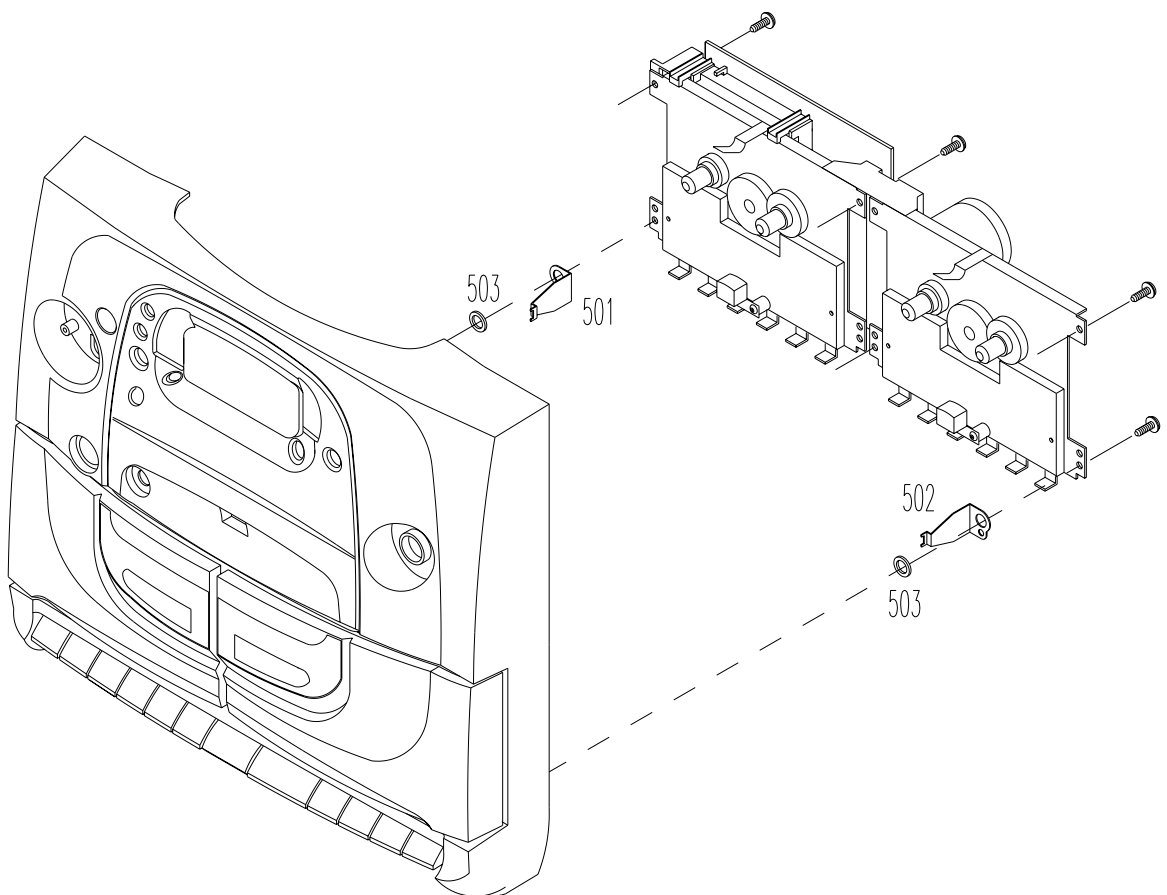
**INFORMATION** : Strong pressure applied on the edges can loosen the Cassette Door.  
To improve this behaviour two metal brackets have been added to protect the hinges. For details see diagram below.

**REMARKS** : The modification has been implemented in production from week 9836 onwards.

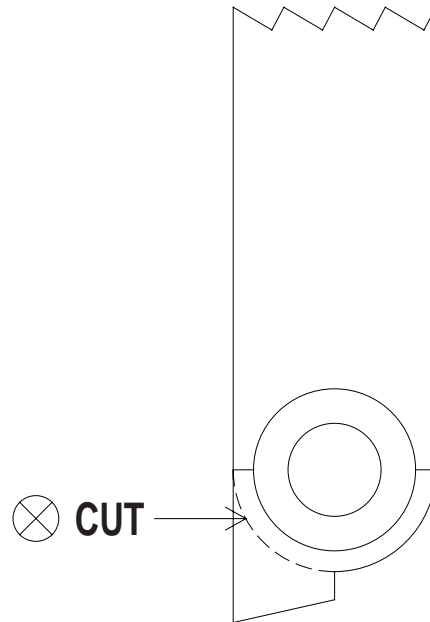
**INFORMATION** : The Handle Bracket Left (pos. 34, 4822 498 10501) is no longer available as service spare part. We suggest to use Handle Bracket Right (pos. 36, 4822 498 10502) as a substitute.  
The stopper end has to be cut as shown in the diagram below.

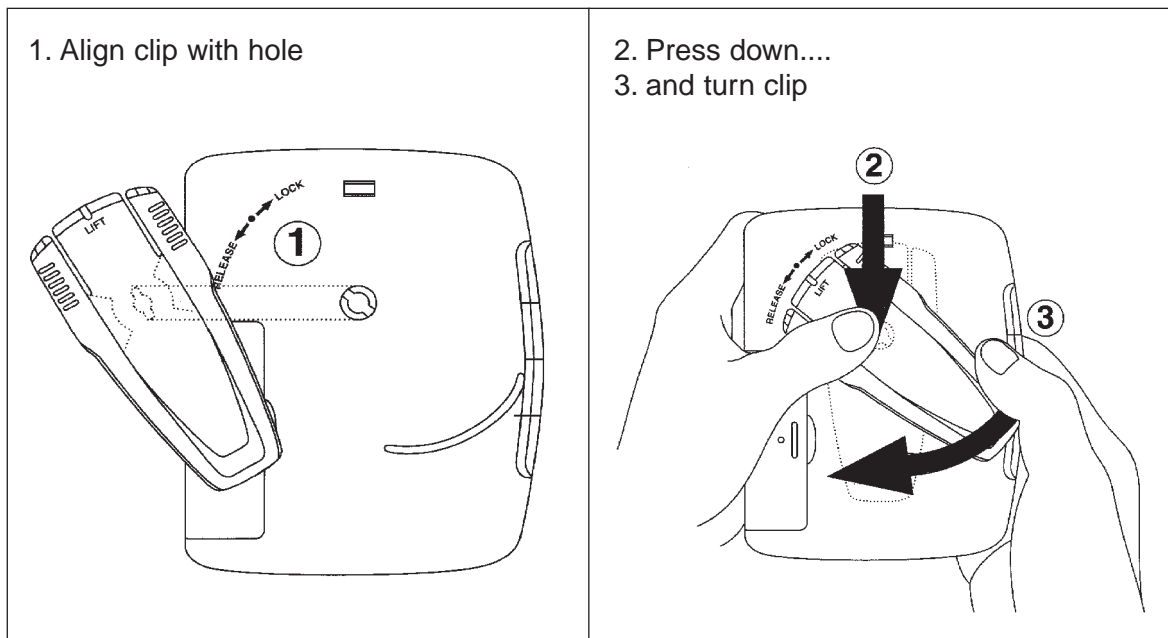
The Belt Clip is broken.

CURE : The belt clip will be broken if it is not properly pressed into the mounting hole on the rear cabinet before turning to LOCK position. The Belt Clip is available via service codenumber 4822 401 11734.

REMARKS : An addendum sheet with diagrams showing how to fix the Belt Clip was added to the set from week 9815 onwards. The belt Clip has also been modified (dimple added and letter "PUSH" engraved).

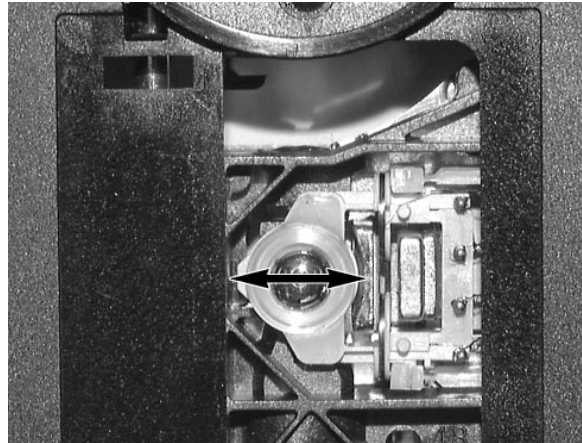
Analysis of exchanged CD-drives has shown, that in a considerable quantity of drives the malfunctions were caused by dirty lens. Before replacing a CD-drive it is therefore recommended to clean the lens and check the functionality of the system again.

The actuator is a very precise mechanical component and may not be damaged in order to guarantee its full function. It is advised to clean the lens gently (don't press too hard) with a soft and clean cotton swab moistened with the special lens cleaner. The direction of cleaning must be in the way as indicated in the picture below.

Because the material of the lens is synthetic and coated with a special anti-reflectivity layer, cleaning must be done with a non-aggressive cleaning fluid. It is advised to use lens cleaner "**KODAK LENS CLEANER CAT 176 71 36**", available in normal photo shops.

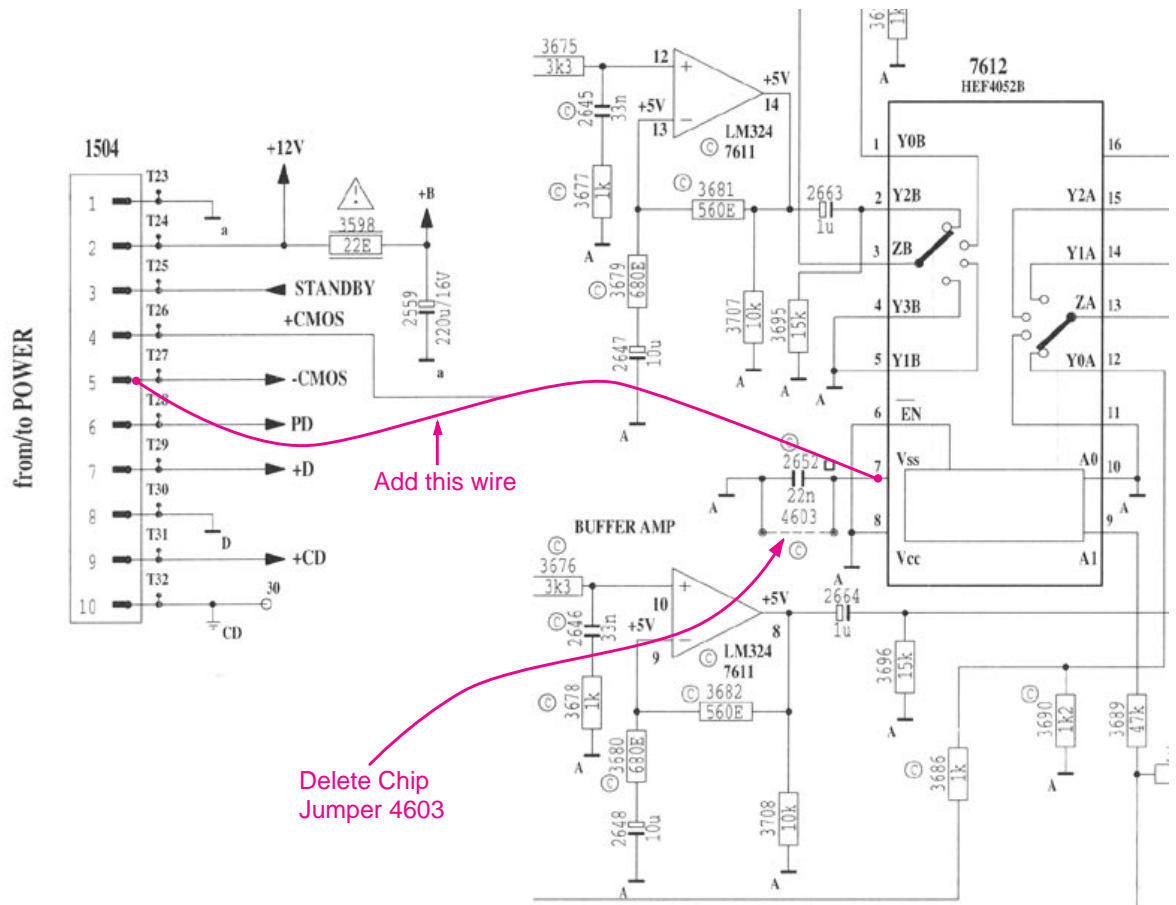
1. Distortion is audible during playback of certain pre-recorded cassettes.
2. Continuous crackling (or clipping) sound is audible during playback of certain CDs (i.e. CDV – Spice Girls/Spiceworld, no. CDV 2850 7243 8 45111 2 8, track 10).

1. Remove chip jumper 4603.
2. Connect VSS of IC 7612 to -5V DC by wire from pin 7 of IC7612 to pin 5 of connector 1504.

For details on this rework, see circuit diagram below.

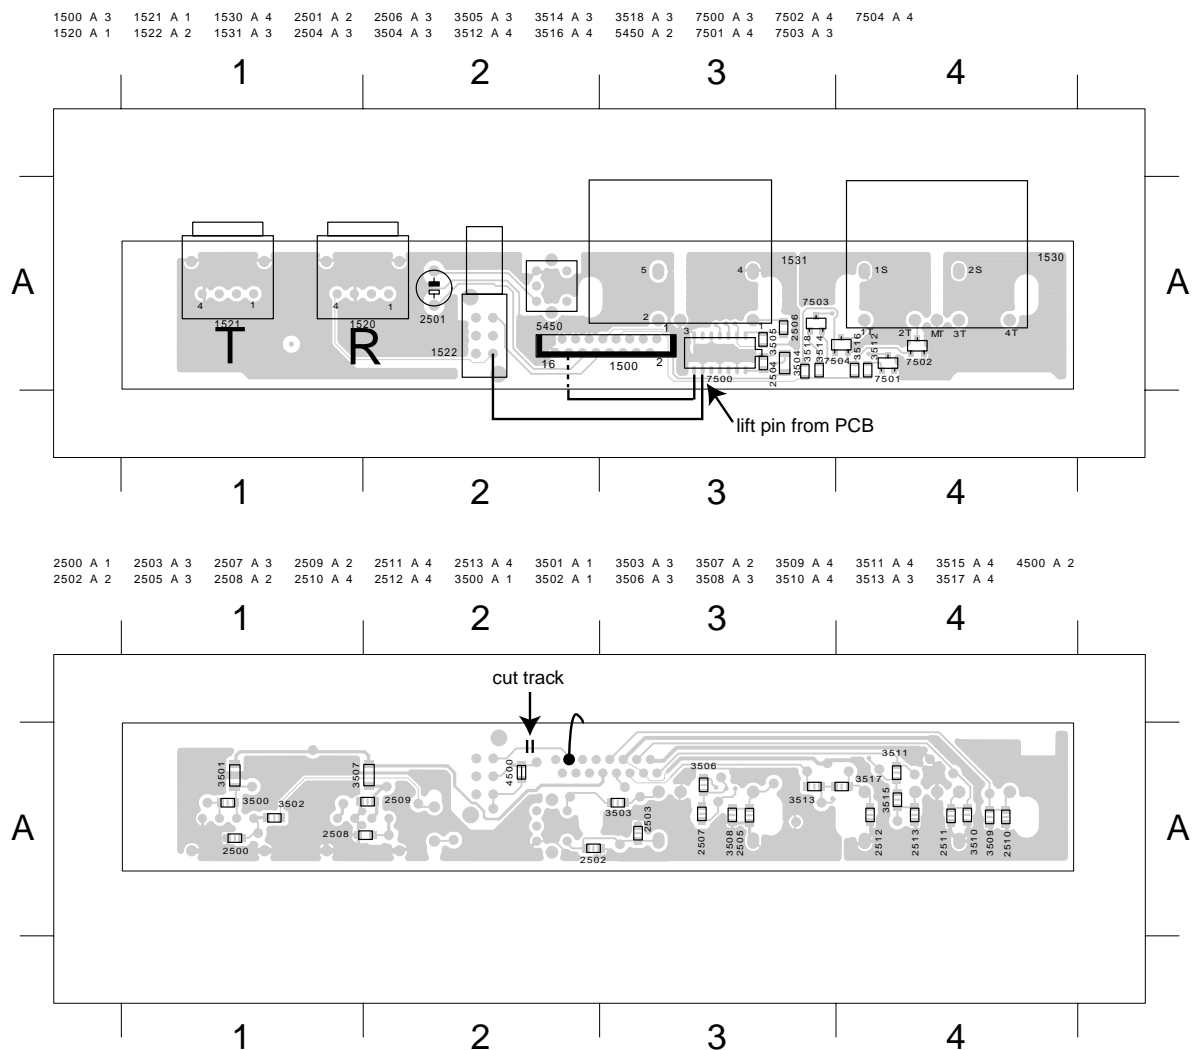
**CURE :** This problem is caused by the optical input device PLR102 (item 1520 on the connector PCB). In case the risetime specification is worse than 50ns, the optical input signal may result in a bad recording. There are 2 solutions possible:

1. Replace PLR102 by TORX174 (Toshiba) with service codenumber 4822 130 91224. C2508 has to be replaced by a short circuit to ground. The risetime specifications of this device are <30ns.
2. Use one of the free inverter ports of device 74HCU04N (item 7500) to improve the optical in signal. This can be done as follows:
  - Connect output 4 of optical device to pin 9 of IC7500.
  - This pin must be lifted from the PCB.
  - Connect pin 8 of IC7500 to pin 14 of connector 1500.
  - Interrupt copper track between pin 14 of connector 1500 to pin 4 of switch 1522 (not mounted).

With this solution, steep flanks will be created on the signal.  
Note that inverting is no problem for a biphase signal.  
See also picture of the modified PCB below.

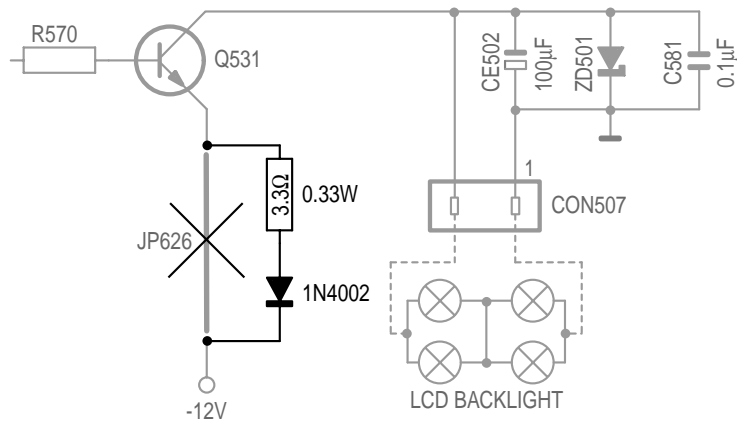
SYMPTOM : **IRIS CODE 1 1 3 B**  
Display backlight lamps are defective.

CURE : The problem is caused by overvoltage.

Following modification on the MAIN BOARD limit the supply voltage:  
Replace jumper JP626 by a diode 1N4002 (5322 130 30684) in series with a resistor 3,3Ω 5% 0,33W (4822 052 10338).

**As preventive action above modification must be implemented in all sets brought in for repair!!**

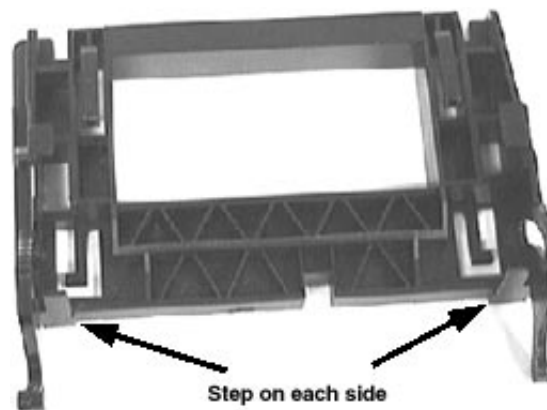
**CURE** : The problem is caused by deformation of the cassette door's plastic springs.

For repair the cassette door must be replaced by an improved cassette door. Improved cassette doors can be recognized by a step at the bottom edge of the door (see picture).

**REMARKS** : Improved cassette doors have been implemented in production from week 9802 onwards (sets with serial no. MA....). See also Service Newsletter AS97.01.17.

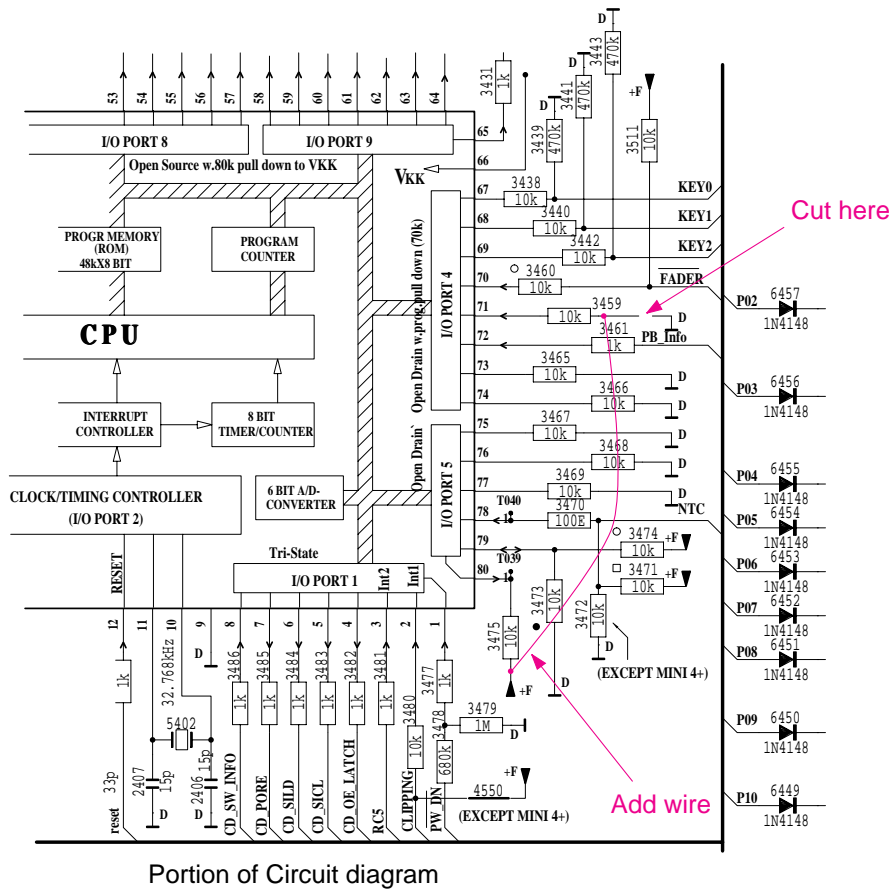
Portion of Circuit diagram

CURE : The phenomenon is caused by mismatch of software and hardware timing. The problem can be solved by the following hardware modification on the front board:  
1. Cut a copper track between resistor 3459 (10kΩ) and ground D.  
2. Connect a short wire between resistor 3459 to +F supply (+5V).  
For details on this rework, see circuit and layout diagram below.

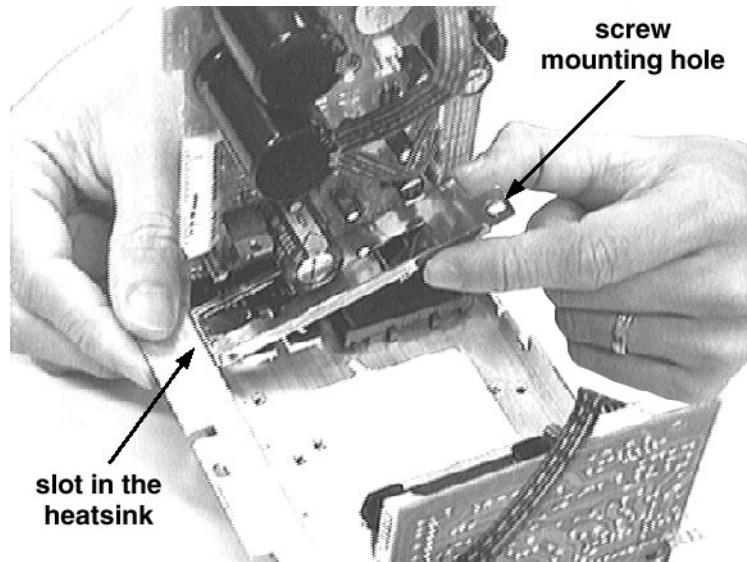
**SYMPTOM** : Power transistor 7302 (BD242BF1) and Dolby Pro-logic decoder 7501 (M69032) are defective.

**CURE** : The metal bracket, clamping transistor 7302 onto the heatsink for proper heat dissipation, is missing. This causes the C-E-line of the transistor to short circuit. As a result the supply voltage of the Dolby Pro-logic decoder becomes 18V, which damages the device.

1. Dismantle the set and take out the Power 1 Module.
2. Insert one end of the metal bracket (4822 402 10969) into the slot provided in the heatsink (see picture below).  
Use a self-tapping screw D2.9x13 to mount the other end of the bracket onto the heatsink. The bracket will press transistor and bridge rectifier onto the heatsink for max. heat dissipation.

Note: In the picture one pc board and the fan/bracket is removed for photographing purpose only. This is not necessary for mounting of metal bracket.

**All sets brought in for repair must be checked if the metal bracket is assembled !!**
