Published by:  
Service Department LOBPA Hong Kong

LINE OF BUSINESS PORTABLE AUDIO

# SERVICE NEWSLETTER

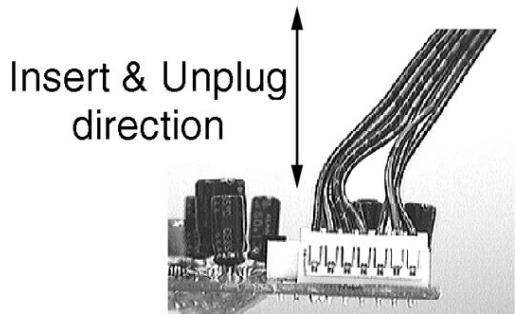
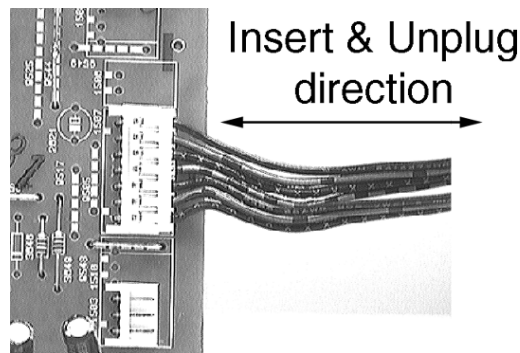
**Correct handling**

- SYMPTOM** : Various failures disappear when the set is opened or when connectors are reconnected.
- CAUSE** : During production some JST connectors were changed from XH type to EH type with smaller head. This new EH type is more fragile and susceptible to deformation during plugging in and out of the connector socket. When it is deformed it will result in poor or intermittent contact.
- CURE** :  
1. During repair service technicians must handle the EH type connectors with care. The correct way to plug it in and out is indicated below.  
2. All EH type connectors with an intermittent contact should be replaced as a preventive action.  
3. All the different wire assemblies had been standardized and are available under the following service codes. For repair application the wires should be cut to the correct length as required in the defective set.

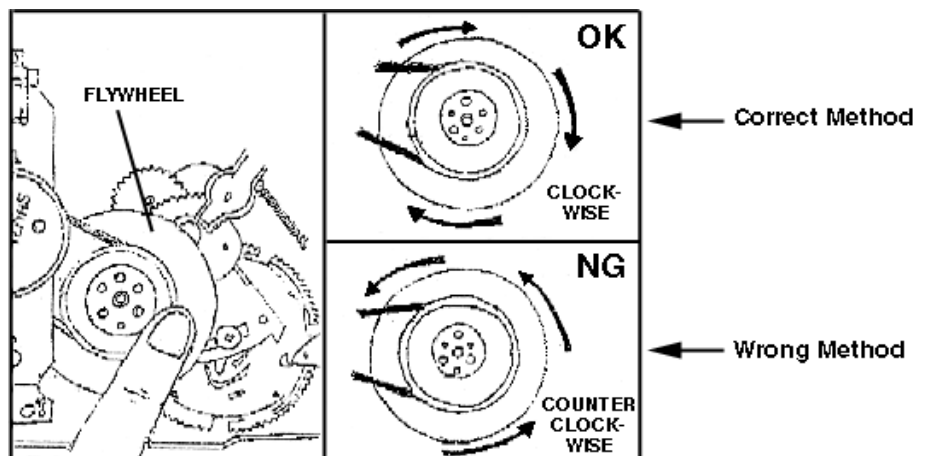
**INFORMATION** : **Repair hint, Tape Mechanism**  
During repair or when the Tape mechanism needs to be reset for any reason, the flywheel can be turned manually. This can be done by turning the flywheel slowly in the clockwise direction. Counter clockwise motion must not be done because it may dent or damage some of the gears in the mechanism. See picture below.

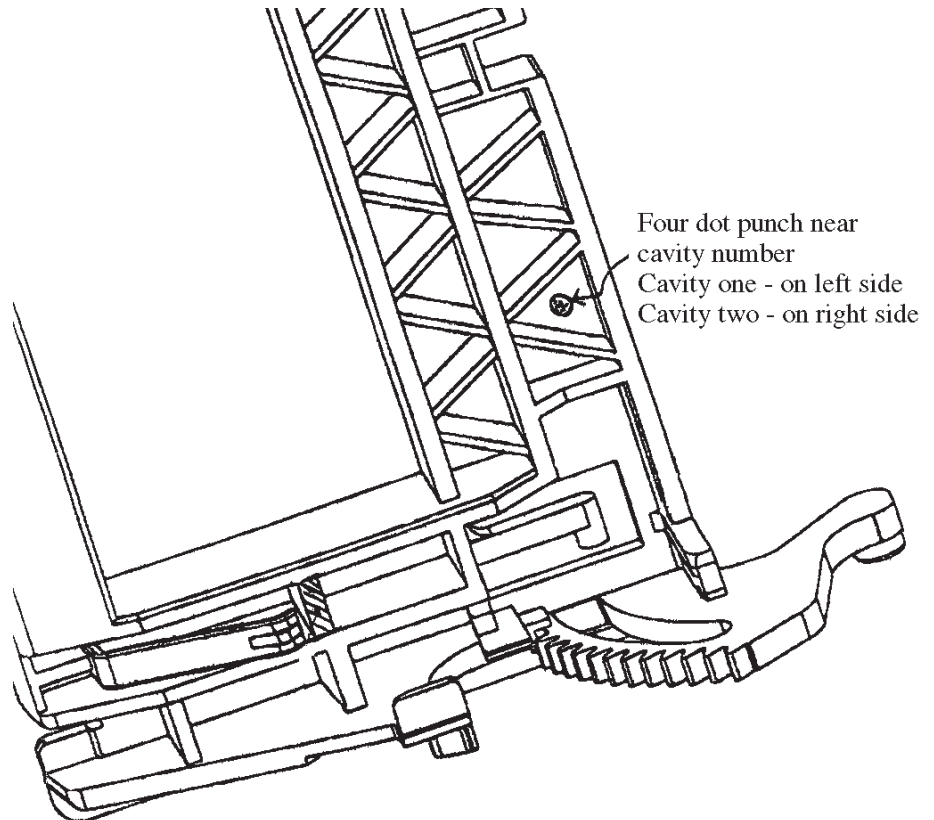
- SYMPTOM** : Cassette door sticks with cassette during eject.
- CURE** : The problem is due to deformation of cassette door's plastic spring causing the cassette to interfere with tape deck capstan during eject. For repair the cassette door must be replaced by the improved cassette door. The improved cassette door can be recognized by 4 dots near the cavity number (see picture below).
- REMARKS** : The service stock at PCS has been checked and is OK. Only improved cassette doors will be delivered. Service code number reads 4822 443 10173.
