Nº 43590

3-jun-15

PRODUCT: DW

MODIFICATION AT THE ALTERNATIVE MOTOR DRIVE

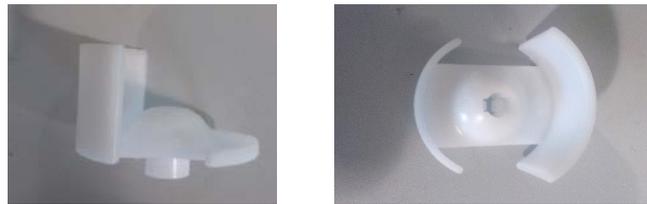
The customer is claiming about a noise and in most of the cases it is not giving any fault code. This noise may not appear in the beginning of the washing program but once the program is in execution

Mainly, the problem occurs due to a design error in the plastic part attached to the motor drive (diaphragm) used to alternate the washing between the top and the bottom of the washing machine. Photos of the Diaphragm:

Remove of the plastic part (diaphragm). The lack of the diaphragm doesn't make any leak in the dishwasher. The spare part (AS0014710) will be supplied as shown in the picture below.

To change the motor drive.
