## Service Bulletin

<b>* Sujet:</b> Bulletin de service pour VC90**	
<b>* Date d'inscription:</b> 20110902	<b>* Effectif à partir du:</b> 20110902

<b>* Applicable aux modèles:</b> VC 9083 EX      VC 9084 DT      VC 9085 FS VC 9086 CH
--

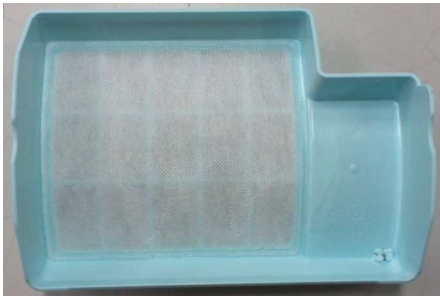
**AVANT: Filtre tout en 1**

<b>* 1) Symptômes / Plainte Consommateur:</b>  Il est difficile de laver le filtre de sécurité du moteur
--

<b>* 2) Problème / Cause:</b>  filtre est coller à la trame.
--

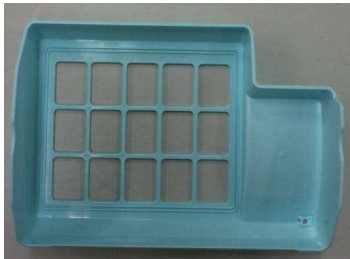
**Après: ajouter le filtre moteur amovible de sécurité**

<b>* 3) Solution:</b>  Le moteur filtre de sécurité est détachable du châssis.
--

Nous développons le filtre amovible.

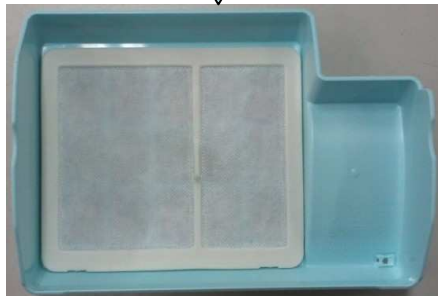
**nouveau moteur filtre de sécurité**

**Châssis**
