Published by:
Service Department BG Audio

SERVICE NEWSLETTER

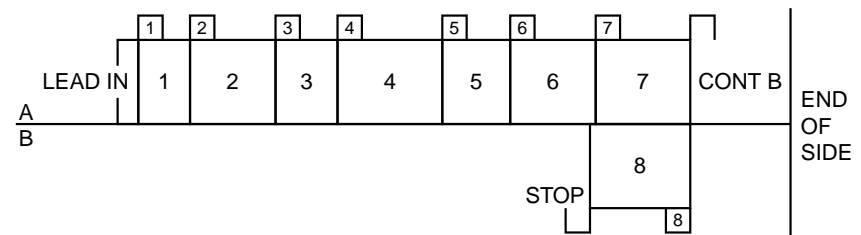
CD911 (EDIT)

In edit mode the CD player selects tracks 1-7 on side A, track 8 on side B. When track 7 has been recorded, the CD911 change over to pause with track 8 selected. The DCC951 writes a "CONT. B" marker on side A, the recorderhead will be reversed, and the recording will continue with track 8. In comparison with a recording on an analogue tape, a greater section of the tape will not be used.

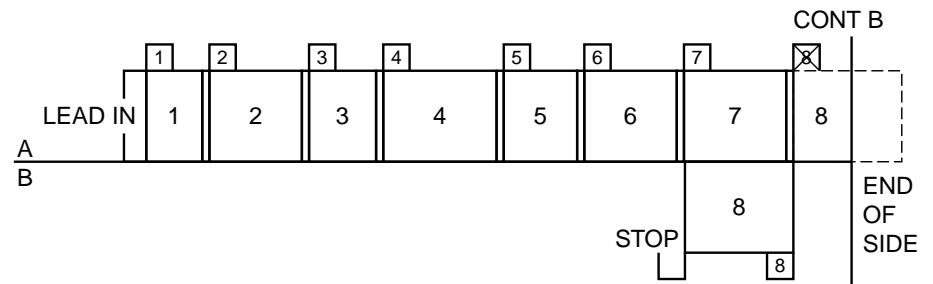
CD951 (NO EDIT POSSIBLE, 4 SEC. AUTOSPACE)

Before the recording of track 8 has been finished, the tape will reach the end of side A . DCC rewinds to startmarker of track 8, replaces it by a "CONT. B" marker and recommences the recording on side B. No tracks will be lost. The disadvantage of the 4 seconds AUTOSPACE is that when recording live recorded CDs, between tracks an undesired pause will be audible. This can only be solved by recording without CD Dubbing(CD SYNCHRO OFF).
