Published by:
Service Department Audio

BUSINESS CREATION UNIT AUDIO

SERVICE NEWSLETTER

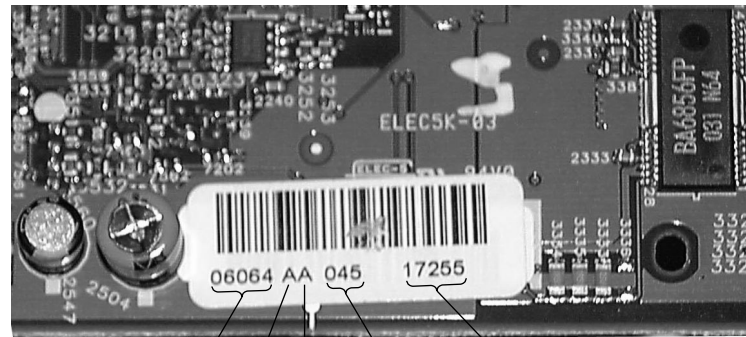
In the following tables there is given reference to “main board labelled with change code”. This label can be found on top at the front side of the main board.

last 5 digits of code number
change code
production line
serial number
production week

When “AA” is printed (as shown in picture above) this means that the main board has once been upgraded before assembling in the set. In this case the status has to be determined by reading out the software versions via service testprogram - the procedure is described in the service manual of the relevant set - or can be found on a sticker on Flash ROM 7208.

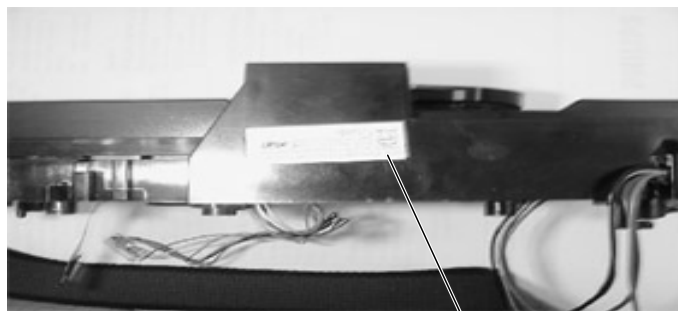
Loader label

INFORMATION : The SD100 has been produced with different Loader/CD-drive combinations. When replacing the CD-drive it is essential to order the correct type of drive. Both, Loaders and CD-drives, can be identified by their type-labels (see pictures below). The corresponding codenumbers can be found in the attached cross-table.

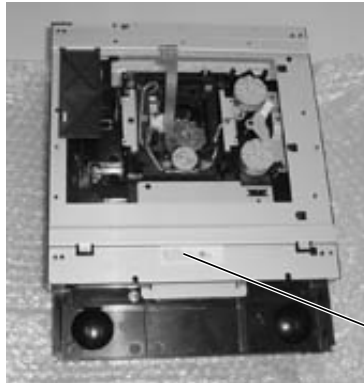
SD300 Unit label

INFORMATION : The SD300 has been produced with different Loader/CD-drive combinations. When replacing the CD-drive it is essential to order the correct type of drive. Both, Loaders and CD-drives, can be identified by their type-labels (see pictures below). The corresponding codenumbers can be found in the attached cross-table.

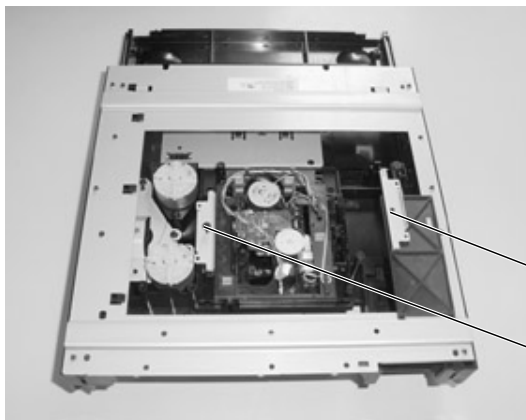
To check the VAM label, the CD-drive must be dismantled as follows:

Remove the steel cover piece

Remove screw

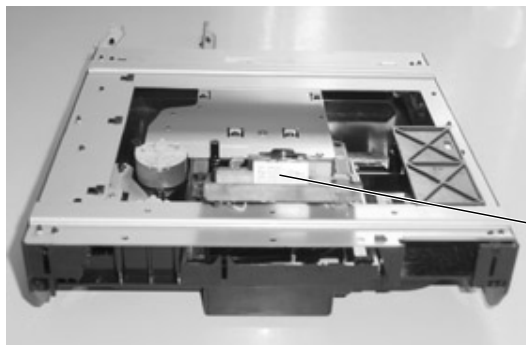
Pull out CD-drive to see the VAM label
