Published by:  
Service Department Audio Systems

# SERVICE NEWSLETTER

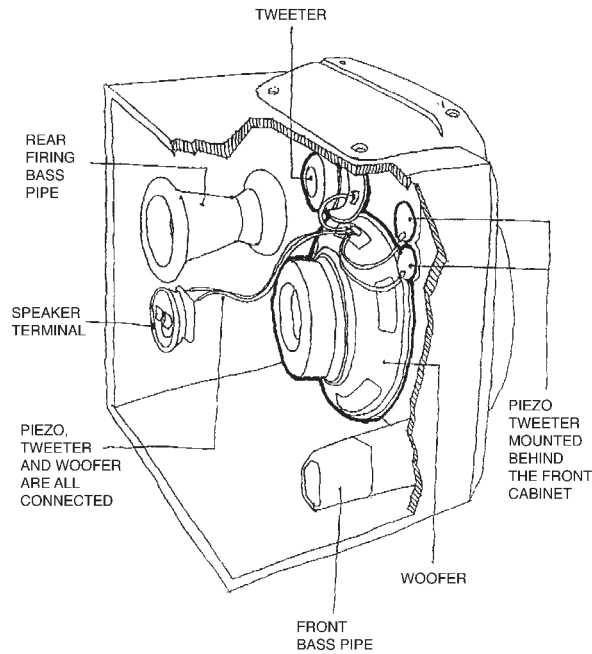
FIG. 1 CUT-OUT VIEW OF SPEAKER BOX-E

**INFORMATION :** The 2 tweeters at the upper part of the 4-way Loudspeaker Box are dummies and for ornamental reasons only. The piezo tweeters are mounted behind the Front cabinet (see fig. 1) instead of the top part. There is no acoustical difference between mounting piezo tweeters on top or on front.
