Published by:  
Service Department LOBPA Hong Kong

LINE OF BUSINESS PORTABLE AUDIO

# SERVICE NEWSLETTER

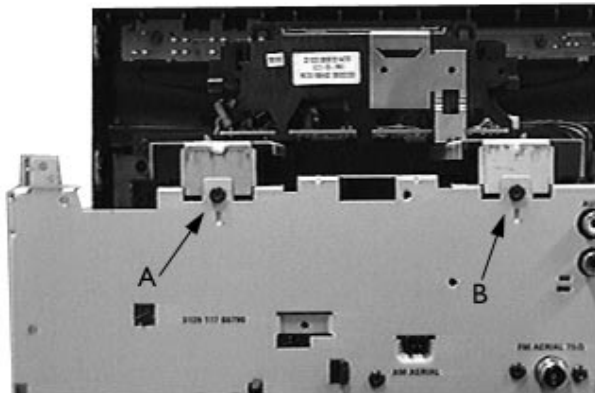
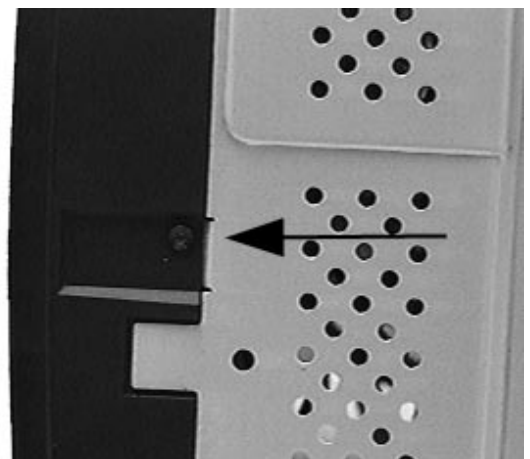
- 1) First remove the top cabinet of the set.
- 2) CD Shortloader Module:  
Loosen the 2 screws indicated in the picture above.
- CD Changer Module:  
Loosen the 2 screws at the back panel & the 2 screws on the front tray of the CDC module.
- 3) Remove the CD module.

- 4) Turn the set aside and loosen the bottom screw as indicated in the picture above.
- 5) Detach the front panel from the bottom panel.

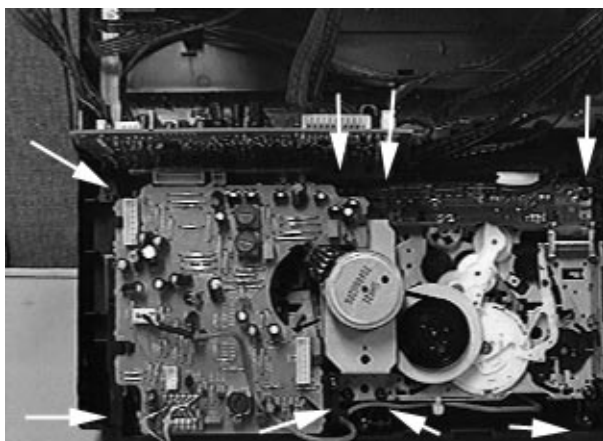
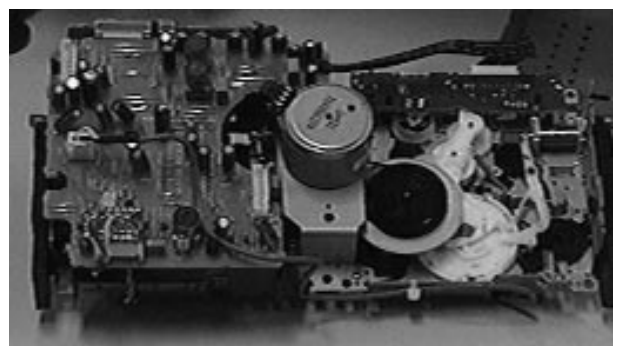
- 6) Loosen the 8 screws of the tape module as indicated in the picture above  
(Note: 4 short screws on top, 4 long screws below).
- 7) Release all wires of the tape module.
- 8) Slowly detach the tape module from the cassette door.
