Service Procedure for Panel, Board and Software Change / Upgrade

GN3TR CHASSIS
KF, KFW segment

SONY®

9-888-719-01

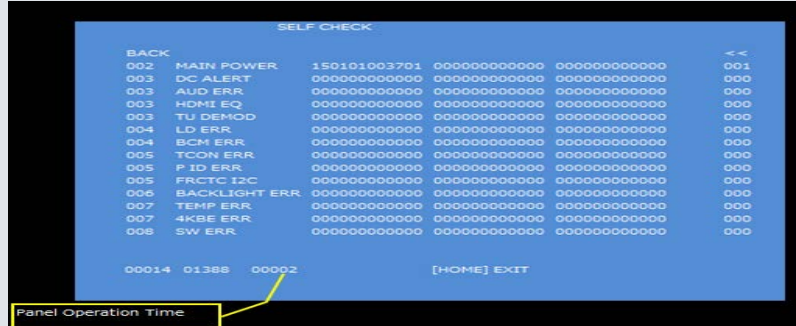
Reset Panel Operation Time

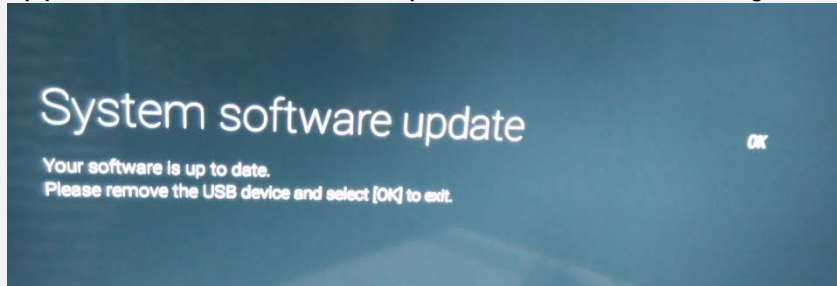
Condition 1: If there is no update of RCD version and recipe condition data is not changed, screen below is appears, then software update is not necessary and can be skipped.

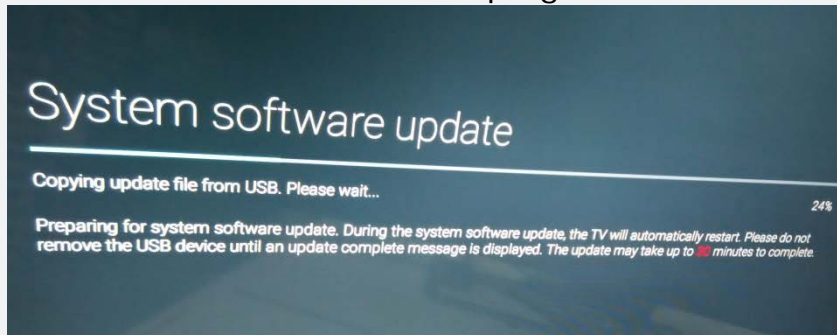
Condition 2: If RCD version is updated or recipe condition data is changed, screen below appears. Then TV will reboot when the progress bar reaches 100%, and the software upgrade will run as usual.
