Service Procedure for Panel, Board and Software Change / Upgrade

GN3TR CHASSIS
KF, KFW segment

9-888-719-01

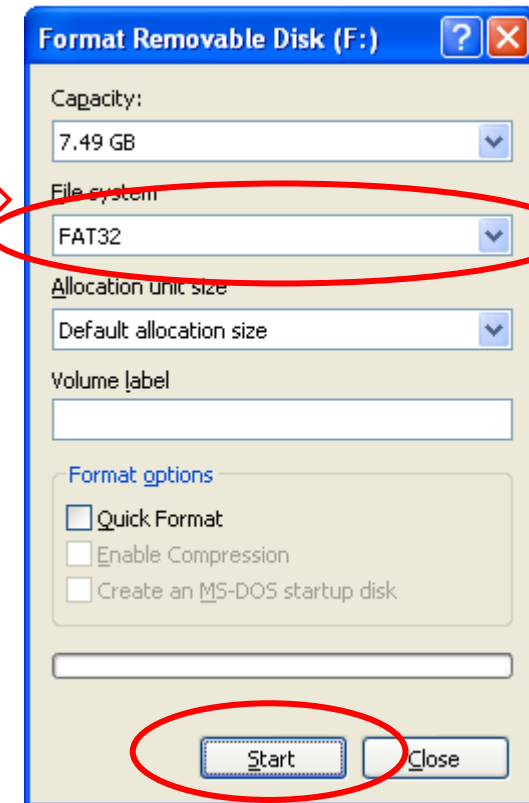
USB Format

1. There is no special restriction on USB memory. If you connect the USB memory to the computer and it is recognized, you can use it.
2. The USB memory should be formatted in FAT32.

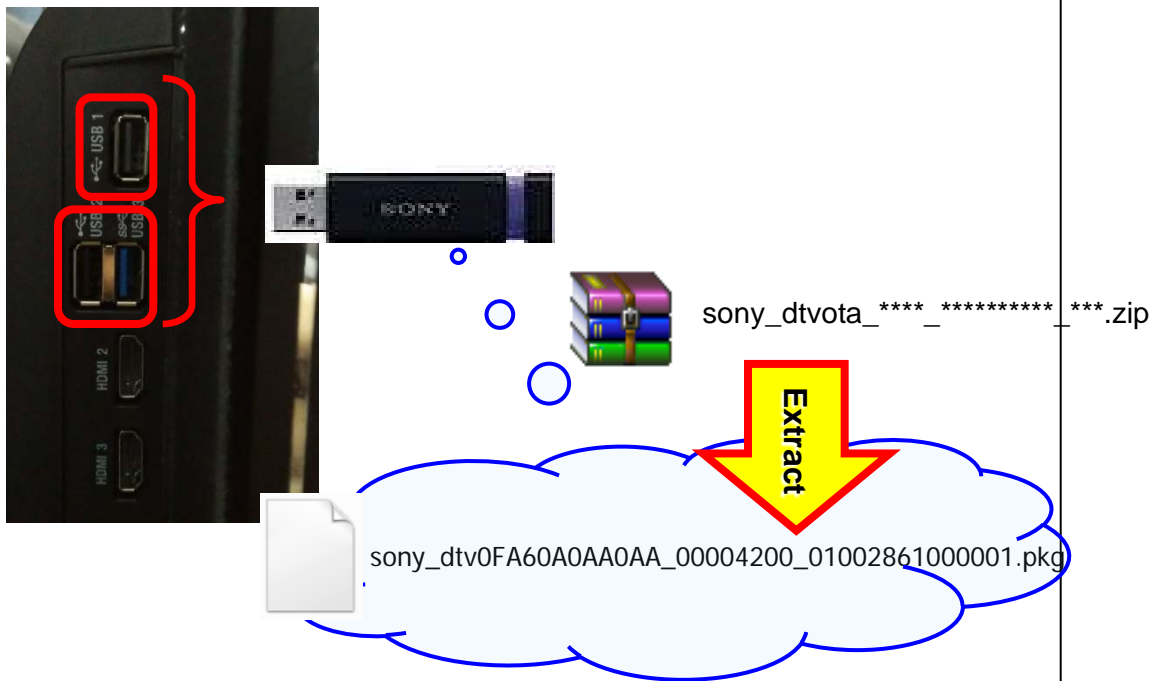
1. Get a dtvota file for upgrade.
2. Extract dtvota file. (e.g. sony_dtvota_****_*****_***.zip)
**** may differ depend on the destination.*
3. Confirm file name. (e.g. sony_dtv*****_*****_*****.pkg)
4. Copy the file under root directory of USB device.

Note: Recommend to use USB Port 2 or 3 for software update.

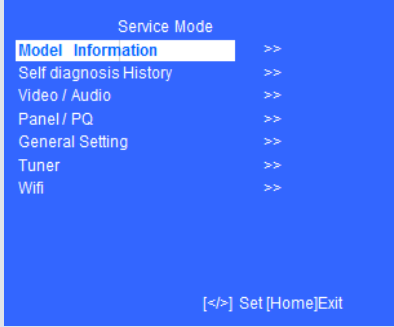
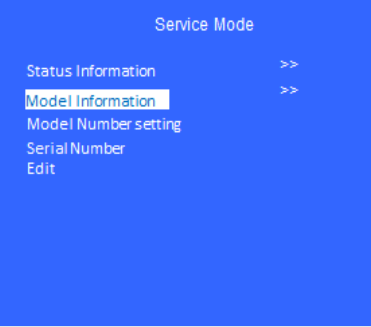
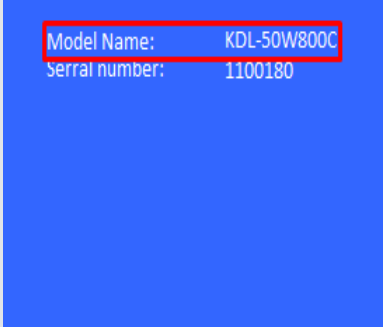
Point	Details/Remarks/Notes			
<p style="text-align: center;">1</p> <p style="text-align: center;">Model name check</p>

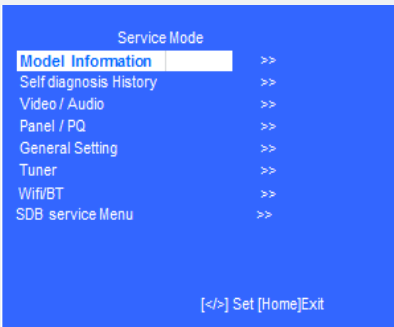
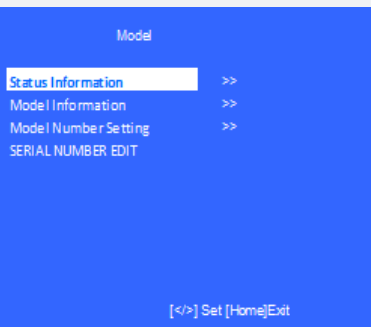
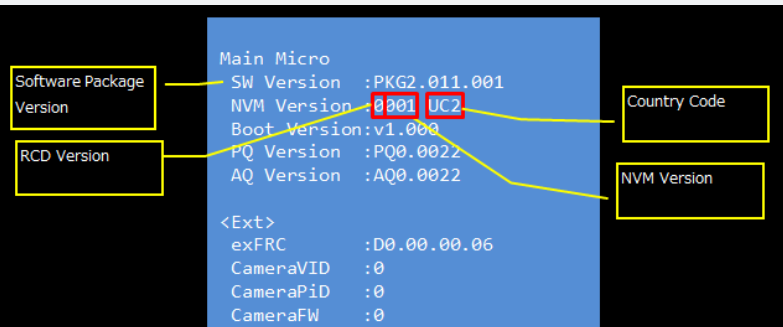
<p style="text-align: center;">2</p> <p style="text-align: center;">SW version, RCD version, NVM version and Country code check</p>

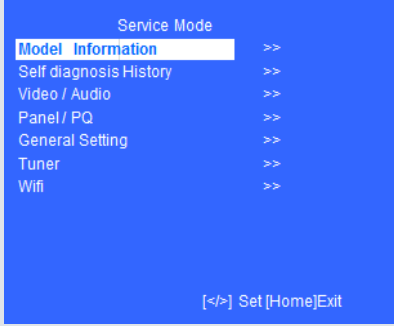
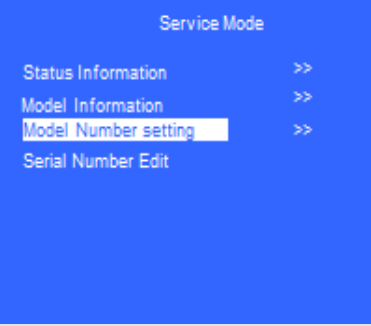
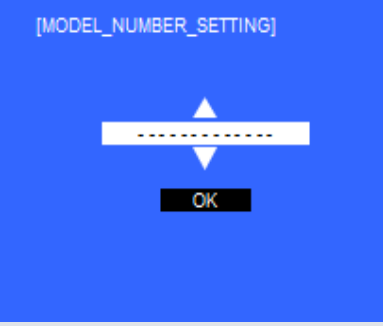
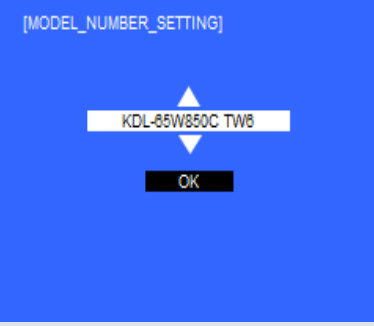
<p style="text-align: center;">3</p> <p style="text-align: center;">Model Number Setting</p>

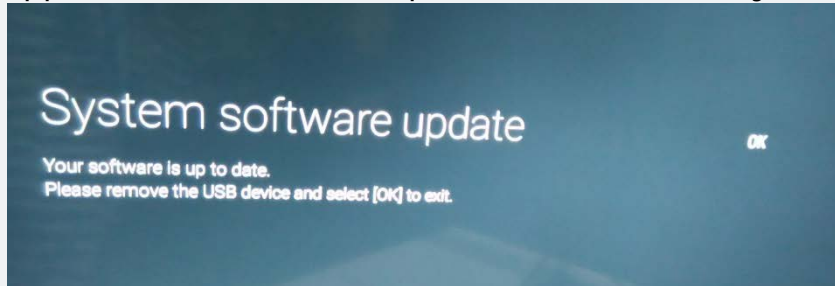
Condition 1: If there is no update of RCD version and recipe condition data is not changed, screen below is appears, then software update is not necessary and can be skipped.

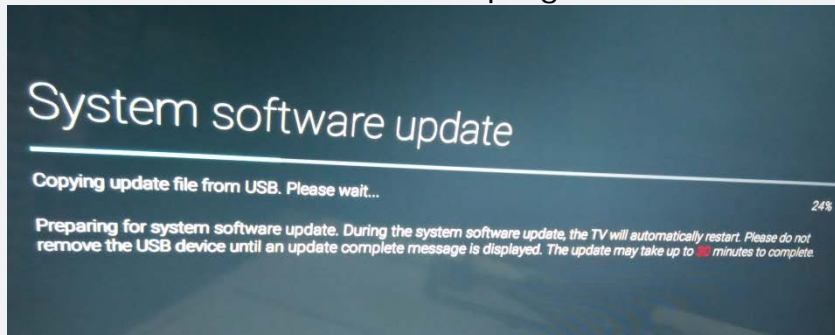
Condition 2: If RCD version is updated or recipe condition data is changed, screen below appears. Then TV will reboot when the progress bar reaches 100%, and the software upgrade will run as usual.
